## Utility Conflict Report

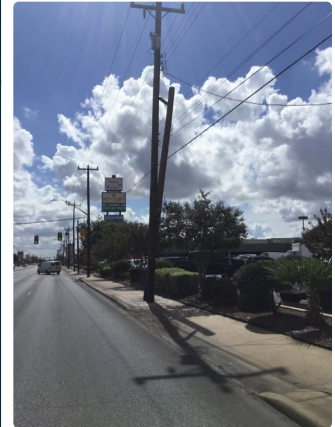
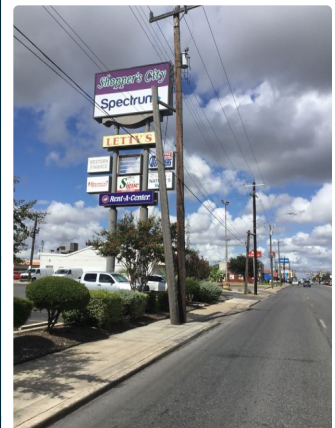
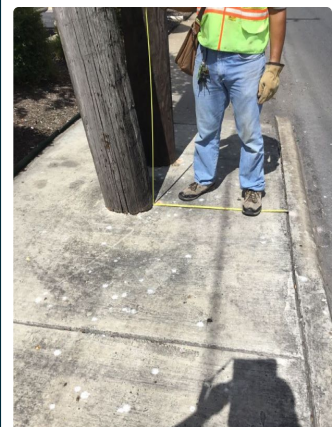
<b>OWNER</b>	<b>Utility</b>	CHARTER	<b>Corridor</b>	SW MILITARY	<b>SITE PHOTOS</b>	
	<b>Contact</b>	FRANK CYPRIAN	<b>ID</b>	1086		
<b>GENERAL INFO</b>	<b>Utility</b>	COMMUNICATIONS				
	<b>Size and Material</b>	OVERHEAD TELECOMM LINES				
	<b>Accessible Route</b>	ASSET IS INSIDE ACCESSIBLE ROUTE				
	<b>Longitudinal or Crossing</b>	LONGITUDINAL				
	<b>Placement Relative to ROW</b>	INSIDE ROW				
<b>LOCATION</b>	<b>Sheet No.</b>	162				
	<b>Station</b>	715+96.33				
	<b>Offset</b>	16.12				
	<b>Latitude</b>	+29.356665				
	<b>Longitude</b>	-98.50205				
<b>SUE</b>	<b>Level of Investigation Req'd</b>	NONE				
	<b>Test Hole No</b>	N/A				
	<b>Test Hole Depth</b>	N/A				
<b>RESOLUTION</b>	<b>Recommended Action</b>	NO CONFLICT				
	<b>Estimated Resolution Date</b>					
	<b>Resolution Status</b>	NO RESOLUTION WAS REQUIRED				
	<b>Comment</b>	Related to utility ID 4196				
<b>Date Collected</b>		<b>Date Modified</b>		12/18/2018 4:05:07 PM
