## Utility Conflict Report

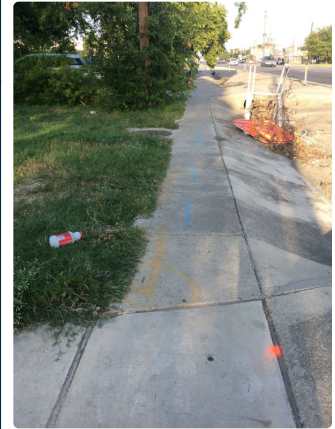
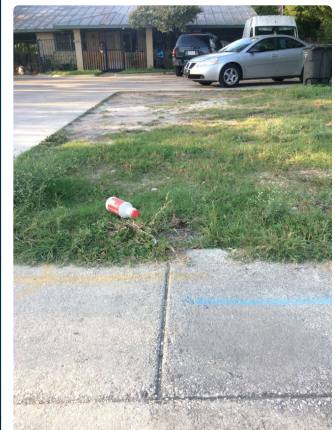
<b>OWNER</b>	<b>Utility</b>	SAWS	<b>Corridor</b>	RIGSBY	<b>SITE PHOTOS</b>
	<b>Contact</b>	ANN PECHE	<b>ID</b>	2094	
<b>GENERAL INFO</b>	<b>Utility</b>	WATER			
	<b>Size and Material</b>	STANDARD WATER METER, CAST IRON			
	<b>Accessible Route</b>	ASSET IS INSIDE ACCESSIBLE ROUTE			
	<b>Longitudinal or Crossing</b>	CROSSING			
	<b>Placement Relative to ROW</b>	INSIDE ROW			
<b>LOCATION</b>	<b>Sheet No.</b>				
	<b>Station</b>	142+30.00			
	<b>Offset</b>				
	<b>Latitude</b>	+29.398401			
	<b>Longitude</b>	-98.40666			
<b>SUE</b>	<b>Level of Investigation Req'd</b>	NONE			
	<b>Test Hole No</b>	N/A			
	<b>Test Hole Depth</b>	N/A			
<b>RESOLUTION</b>	<b>Recommended Action</b>	NO CONFLICT			
	<b>Estimated Resolution Date</b>				
	<b>Resolution Status</b>	NO RESOLUTION WAS REQUIRED			
	<b>Comment</b>	Meter adjacent to back of sidewalk Unable to open lid			
<b>Date Collected</b>		8/14/2017 7:04:20 PM		<b>Date Modified</b> 11/28/2018 6:59:12 AM
