## Utility Conflict Report

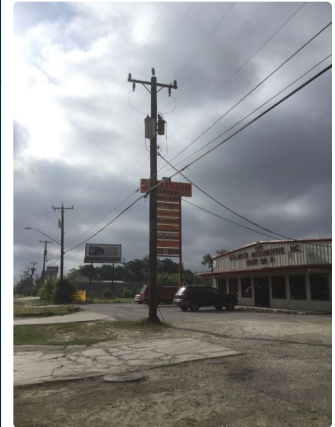
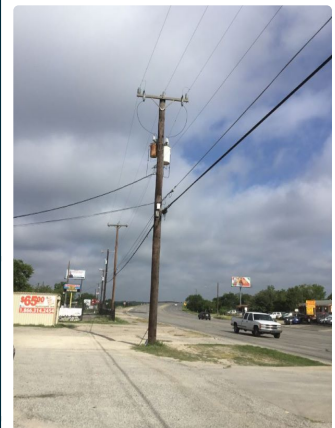
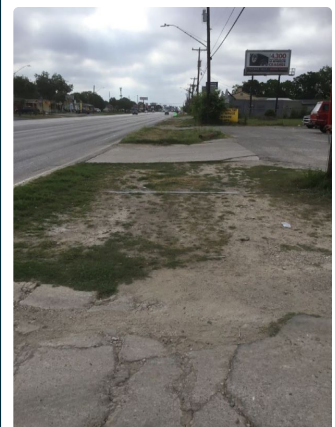
<b>OWNER</b>	<b>Utility</b>	CPS	<b>Corridor</b>	SW MILITARY	<b>SITE PHOTOS</b>
	<b>Contact</b>	JAKE MARTINEZ	<b>ID</b>	3090	
<b>GENERAL INFO</b>	<b>Utility</b>	ELECTRIC			
	<b>Size and Material</b>	STANDARD POWER POLE, TIMBER			
	<b>Accessible Route</b>	ASSET IS INSIDE ACCESSIBLE ROUTE			
	<b>Longitudinal or Crossing</b>	CROSSING			
	<b>Placement Relative to ROW</b>	INSIDE ROW			
<b>LOCATION</b>	<b>Sheet No.</b>	121			
	<b>Station</b>	510+46.03			
	<b>Offset</b>	31.434			
	<b>Latitude</b>	+29.358789			
	<b>Longitude</b>	-98.56641			
<b>SUE</b>	<b>Level of Investigation Req'd</b>	NONE			
	<b>Test Hole No</b>	N/A			
	<b>Test Hole Depth</b>	N/A			
<b>RESOLUTION</b>	<b>Recommended Action</b>	NO CONFLICT			
	<b>Estimated Resolution Date</b>	8/14/2018			
	<b>Resolution Status</b>	NO RESOLUTION WAS REQUIRED			
	<b>Comment</b>	Back of curb to pole = 18'-0" No pole ID			
<b>Date Collected</b>		7/19/2018 9:17:54 AM		<b>Date Modified</b> 11/28/2018 6:59:12 AM
