Utility Conflict Report

OWNER	Utility	SAWS	Corridor	SW MILITARY	SITE PHOTOS		
	Contact	ANN PECHE	ID	3093			
GENERAL INFO	Utility	WATER

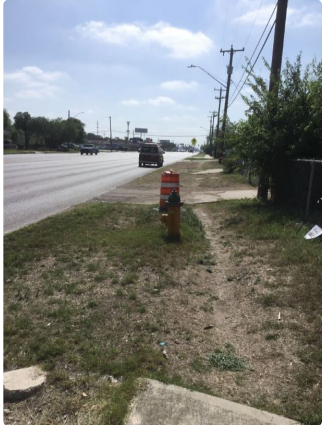
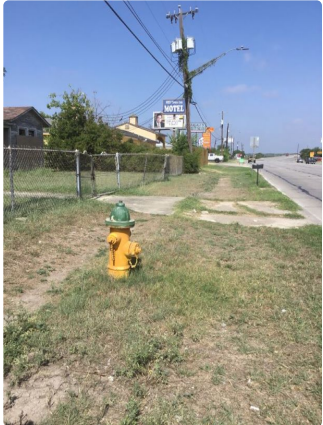
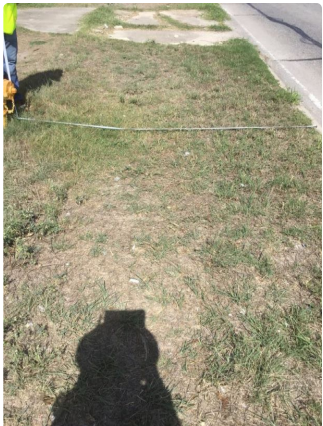
Size and Material	STANDARD FIRE HYDRANT					
	Accessible Route	ASSET IS INSIDE ACCESSIBLE ROUTE					
	Longitudinal or Crossing	CROSSING					
	Placement Relative to ROW	INSIDE ROW					
LOCATION	Sheet No.	123

Test Hole No	N/A					
	Test Hole Depth	N/A					
RESOLUTION	Recommended Action	NO CONFLICT					
	Estimated Resolution Date	8/14/2018					
	Resolution Status	NO RESOLUTION WAS REQUIRED					
	Comment	Back of curb to hydrant = 8'-7" Fence to hydrant = 7'-4"					
Date Collected		7/19/2018 10:34:47 AM		Date Modified		11/28/2018 6:59:12 AM
