## Utility Conflict Report

<b>OWNER</b>	<b>Utility</b>	CPS	<b>Corridor</b>	SW MILITARY	<b>SITE PHOTOS</b>		
	<b>Contact</b>	JAKE MARTINEZ	<b>ID</b>	3109			
<b>GENERAL INFO</b>	<b>Utility</b>	ELECTRIC

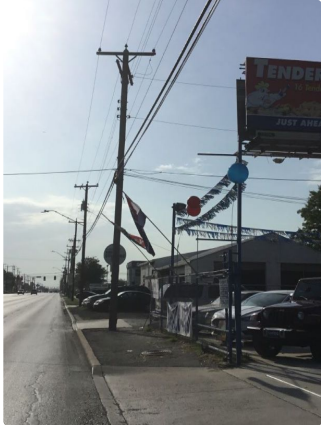
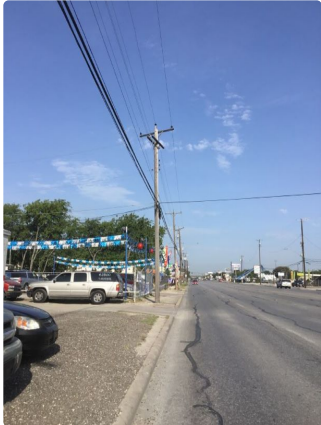
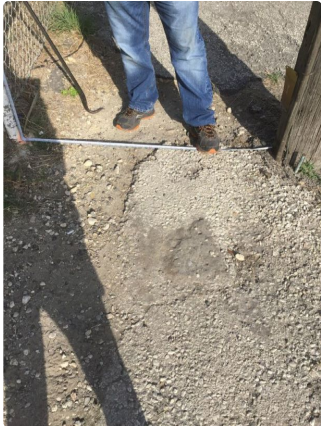
<b>Size and Material</b>	STANDARD POWER POLE, TIMBER					
	<b>Accessible Route</b>	ASSET IS INSIDE ACCESSIBLE ROUTE					
	<b>Longitudinal or Crossing</b>	CROSSING					
	<b>Placement Relative to ROW</b>	INSIDE ROW					
<b>LOCATION</b>	<b>Sheet No.</b>	132

<b>Test Hole No</b>	N/A					
	<b>Test Hole Depth</b>	N/A					
<b>RESOLUTION</b>	<b>Recommended Action</b>	NO CONFLICT					
	<b>Estimated Resolution Date</b>						
	<b>Resolution Status</b>	NO RESOLUTION WAS REQUIRED					
	<b>Comment</b>	Fence to pole = 4'-0" Back of curb to fence = 8'-3" Back of curb to pole = 3'-3" No pole ID
