Utility Conflict Report

OWNER	Utility	CPS	Corridor	SW MILITARY	SITE PHOTOS	
	Contact	JAKE MARTINEZ	ID	3137		
GENERAL INFO	Utility	ELECTRIC

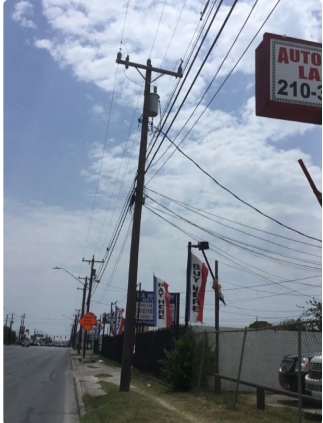
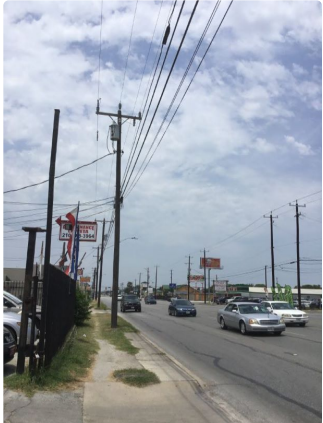
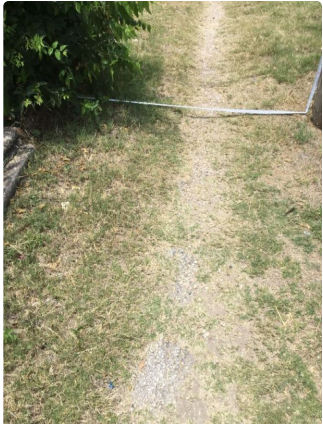
Size and Material	STANDARD POWER POLE, TIMBER				
	Accessible Route	ASSET IS INSIDE ACCESSIBLE ROUTE				
	Longitudinal or Crossing	CROSSING				
	Placement Relative to ROW	INSIDE ROW				
LOCATION	Sheet No.	136

Estimated Resolution Date					
	Resolution Status	NO RESOLUTION WAS REQUIRED				
	Comment	Fence to pole = 5'-3" Back of curb to pole = 3'-3" Back of curb to fence = 9'-6" Sidewalk width = 3'-0" No Pole ID CATV cable				
Date Collected		7/24/2018 1:00:54 PM		Date Modified	11/28/2018 6:59:12 AM

Station	556+01.96				
	Offset	15.9474				
	Latitude	+29.357493				
	Longitude	-98.55227				
SUE	Level of Investigation Req'd	NONE				
	Test Hole No	N/A				
	Test Hole Depth	N/A				
RESOLUTION	Recommended Action	NO CONFLICT
