## Utility Conflict Report

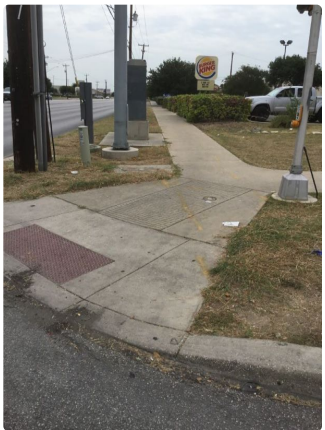
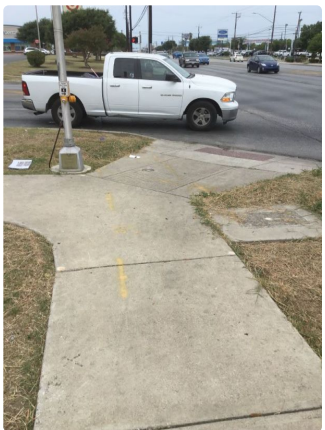
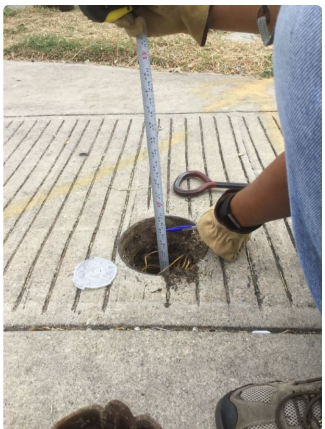
<b>OWNER</b>	<b>Utility</b>	CPS	<b>Corridor</b>	SW MILITARY	<b>SITE PHOTOS</b>		
	<b>Contact</b>	BILL FEY	<b>ID</b>	3152			
<b>GENERAL INFO</b>	<b>Utility</b>	GAS					
	<b>Size and Material</b>	STANDARD GAS VALVE, CAST IRON					
	<b>Accessible Route</b>	ASSET IS INSIDE ACCESSIBLE ROUTE					
	<b>Longitudinal or Crossing</b>	CROSSING					
	<b>Placement Relative to ROW</b>	INSIDE ROW					
<b>LOCATION</b>	<b>Sheet No.</b>	143					
	<b>Station</b>	590+82.18					
	<b>Offset</b>	27.42					
	<b>Latitude</b>	+29.356479					
	<b>Longitude</b>	-98.54125					
<b>SUE</b>	<b>Level of Investigation Req'd</b>	NONE					
	<b>Test Hole No</b>	N/A					
	<b>Test Hole Depth</b>	N/A					
<b>RESOLUTION</b>	<b>Recommended Action</b>	MINIMIZE - PROTECT IN PLACE					
	<b>Estimated Resolution Date</b>						
	<b>Resolution Status</b>	UTILITY OWNER INFORMED OF UTILITY					
	<b>Comment</b>	Valve to front of sidewalk = 2'-6" Top of valve to surface = 3'-9 1/2" Lid flange thickness = 3/8" Total lid thickness = 1 7/8"
