## Utility Conflict Report

<b>OWNER</b>	<b>Utility</b>	SAWS	<b>Corridor</b>	SW MILITARY	<b>SITE PHOTOS</b>		
	<b>Contact</b>	ANN PECHE	<b>ID</b>	3178			
<b>GENERAL INFO</b>	<b>Utility</b>	SANITARY SEWER

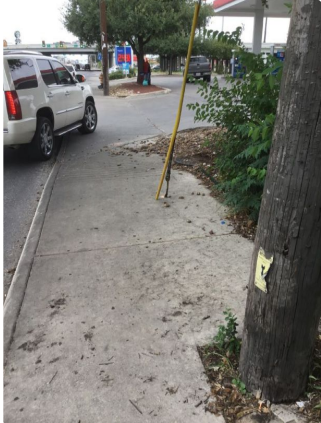
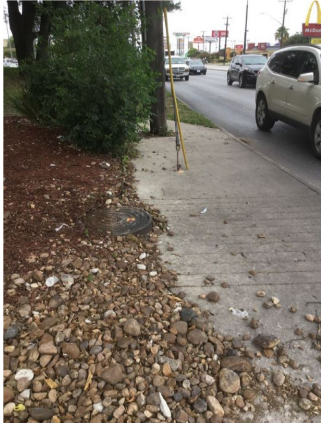
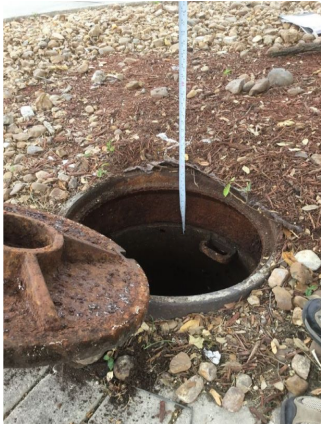
<b>Size and Material</b>	STANDARD MANHOLE, CAST IRON					
	<b>Accessible Route</b>	ASSET IS INSIDE ACCESSIBLE ROUTE					
	<b>Longitudinal or Crossing</b>	CROSSING					
	<b>Placement Relative to ROW</b>	INSIDE ROW					
<b>LOCATION</b>	<b>Sheet No.</b>	148

<b>Test Hole No</b>	N/A					
	<b>Test Hole Depth</b>	N/A					
<b>RESOLUTION</b>	<b>Recommended Action</b>	NO CONFLICT					
	<b>Estimated Resolution Date</b>						
	<b>Resolution Status</b>	NO RESOLUTION WAS REQUIRED					
	<b>Comment</b>	Manhole to back of curb = 6'-3" Bottom of manhole ring to surface = 8" Lid thickness = 1 1/2"
