Utility Conflict Report

OWNER	Utility	SAWS	Corridor	BANDERA	SITE PHOTOS	
	Contact	ANN PECHE	ID	3180		
GENERAL INFO	Utility	WATER

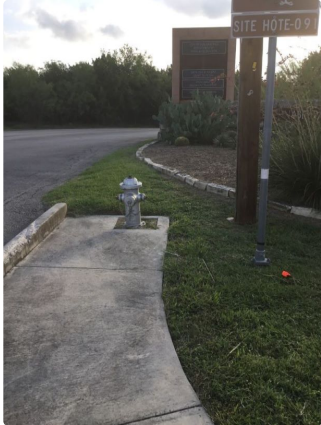
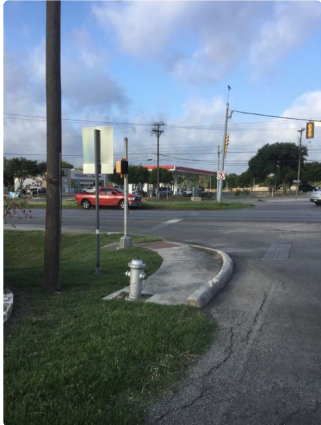
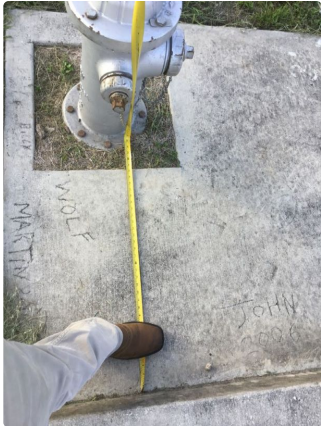
Size and Material	STANDARD FIRE HYDRANT				
	Accessible Route	ASSET IS INSIDE ACCESSIBLE ROUTE				
	Longitudinal or Crossing	CROSSING				
	Placement Relative to ROW	INSIDE ROW				
LOCATION	Sheet No.

Estimated Resolution Date	8/28/2018				
	Resolution Status	NO RESOLUTION WAS REQUIRED				
	Comment	Back of curb to hydrant = 2'-10" Back of sidewalk to hydrant = 13 5/8"				
Date Collected		8/16/2018 8:11:58 AM		Date Modified	11/28/2018 6:59:12 AM

Station					
	Offset					
	Latitude	+29.532066				
	Longitude	-98.64473				
SUE	Level of Investigation Req'd	NONE				
	Test Hole No	N/A				
	Test Hole Depth	N/A				
RESOLUTION	Recommended Action	NO CONFLICT
