## Utility Conflict Report

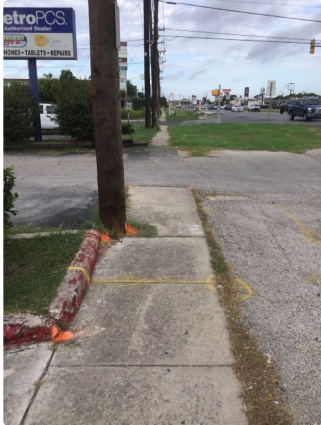
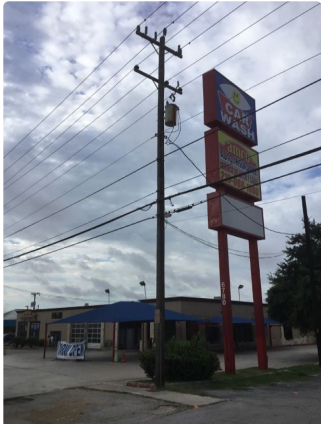
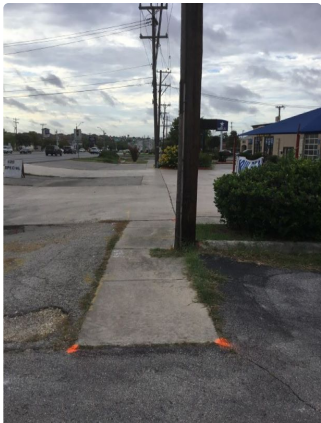
<b>OWNER</b>	<b>Utility</b>	CPS	<b>Corridor</b>	BANDERA	<b>SITE PHOTOS</b>
	<b>Contact</b>	JAKE MARTINEZ	<b>ID</b>	3227	
<b>GENERAL INFO</b>	<b>Utility</b>	ELECTRIC			
	<b>Size and Material</b>	STANDARD POWER POLE, TIMBER			
	<b>Accessible Route</b>	ASSET IS INSIDE ACCESSIBLE ROUTE			
	<b>Longitudinal or Crossing</b>	CROSSING			
	<b>Placement Relative to ROW</b>	INSIDE ROW			
<b>LOCATION</b>	<b>Sheet No.</b>				
	<b>Station</b>				
	<b>Offset</b>				
	<b>Latitude</b>	+29.495931			
	<b>Longitude</b>	-98.61990			
<b>SUE</b>	<b>Level of Investigation Req'd</b>	NONE			
	<b>Test Hole No</b>	N/A			
	<b>Test Hole Depth</b>	N/A			
<b>RESOLUTION</b>	<b>Recommended Action</b>	NO CONFLICT			
	<b>Estimated Resolution Date</b>	8/28/2018			
	<b>Resolution Status</b>	NO RESOLUTION WAS REQUIRED			
	<b>Comment</b>	Typical sidewalk width = 4'-0" No pole ID Pole diameter = 12"			
	<b>Date Collected</b>		8/20/2018 8:35:44 AM	<b>Date Modified</b>
