Utility Conflict Report

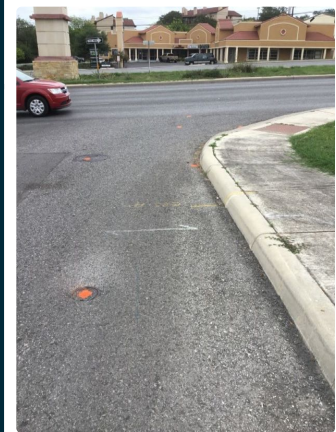
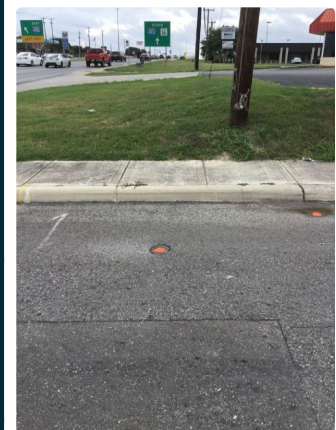
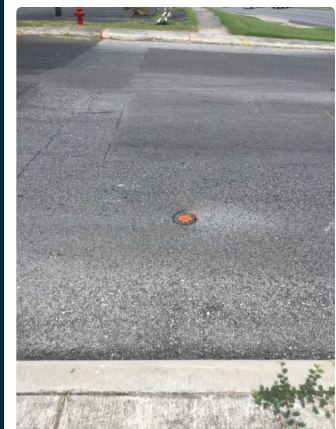
OWNER	Utility	SAWS	Corridor	BANDERA	SITE PHOTOS
	Contact	ANN PECHE	ID	3239	
GENERAL INFO	Utility	WATER			
	Size and Material	STANDARD WATER VALVE, CAST IRON			
	Accessible Route	ASSET IS OUTSIDE ACCESSIBLE ROUTE			
	Longitudinal or Crossing	CROSSING			
	Placement Relative to ROW	INSIDE ROW			
LOCATION	Sheet No.				
	Station				
	Offset				
	Latitude	+29.489182			
	Longitude	-98.61071			
SUE	Level of Investigation Req'd	NONE			
	Test Hole No	N/A			
	Test Hole Depth	N/A			
RESOLUTION	Recommended Action	NO CONFLICT			
	Estimated Resolution Date	8/28/2018			
	Resolution Status	NO RESOLUTION WAS REQUIRED			
	Comment	Face of curb to valve = 4'-6" Unable to open lid			
Date Collected		8/20/2018 10:11:34 AM		Date Modified 11/28/2018 6:59:12 AM
