## Utility Conflict Report

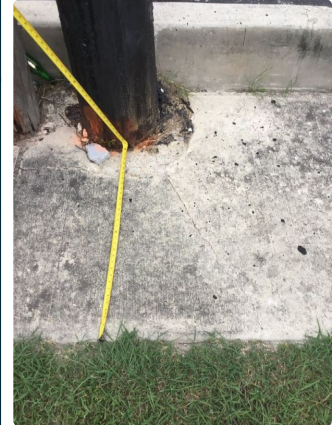
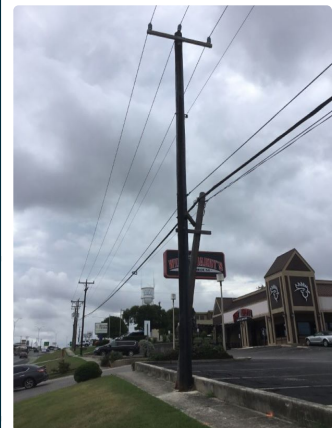
<b>OWNER</b>	<b>Utility</b>	CPS	<b>Corridor</b>	BANDERA	<b>SITE PHOTOS</b>		
	<b>Contact</b>	JAKE MARTINEZ	<b>ID</b>	3245			
<b>GENERAL INFO</b>	<b>Utility</b>	ELECTRIC					
	<b>Size and Material</b>	STANDARD POWER POLE, TIMBER					
	<b>Accessible Route</b>	ASSET IS INSIDE ACCESSIBLE ROUTE					
	<b>Longitudinal or Crossing</b>	CROSSING					
	<b>Placement Relative to ROW</b>	INSIDE ROW					
<b>LOCATION</b>	<b>Sheet No.</b>						
	<b>Station</b>						
	<b>Offset</b>						
	<b>Latitude</b>	+29.490447					
	<b>Longitude</b>	-98.61252					
<b>SUE</b>	<b>Level of Investigation Req'd</b>	NONE					
	<b>Test Hole No</b>	N/A					
	<b>Test Hole Depth</b>	N/A					
<b>RESOLUTION</b>	<b>Recommended Action</b>	NO CONFLICT					
	<b>Estimated Resolution Date</b>	8/28/2018					
	<b>Resolution Status</b>	NO RESOLUTION WAS REQUIRED					
	<b>Comment</b>	Front of sidewalk to pole = 2'-9" No pole ID Pole diameter = 12"					
<b>Date Collected</b>		8/20/2018 10:30:13 AM		<b>Date Modified</b>		11/28/2018 6:59:12 AM
