Utility Conflict Report

OWNER	Utility	CPS	Corridor	BANDERA	SITE PHOTOS	
	Contact	BILL FEY	ID	3902		
GENERAL INFO	Utility	GAS

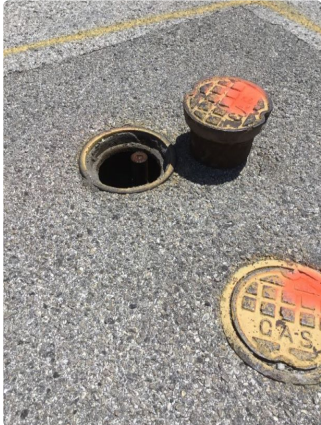
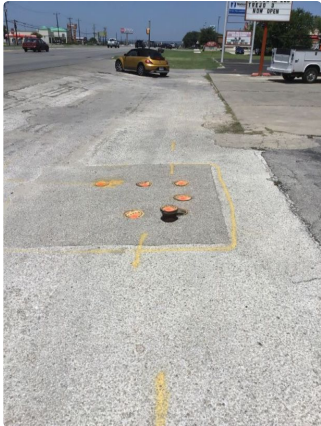
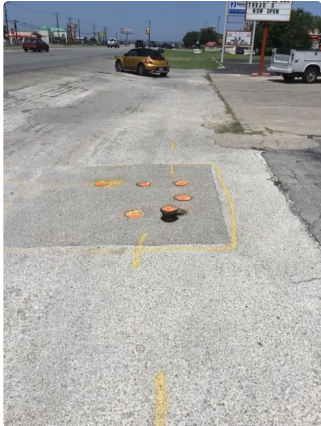
Size and Material	STANDARD GAS VALVE, CAST IRON				
	Accessible Route	ASSET IS OUTSIDE ACCESSIBLE ROUTE				
	Longitudinal or Crossing	CROSSING				
	Placement Relative to ROW	INSIDE ROW				
LOCATION	Sheet No.	246

Estimated Resolution Date					
	Resolution Status	UTILITY CONFLICT CREATED				
	Comment	Gas valves Top of valve to surface = 0" (top right valve in first image)				
Date Collected		8/17/2018 1:15:06 PM		Date Modified	11/21/2018 2:51:37 PM

Test Hole No	N/A				
	Test Hole Depth	N/A				
RESOLUTION	Recommended Action	MINIMIZE - PROTECT IN PLACE
