Utility Conflict Report

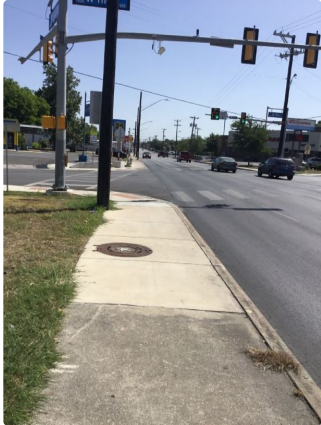
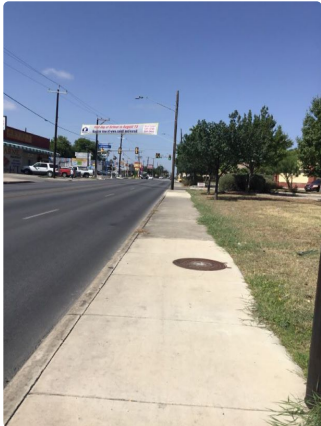
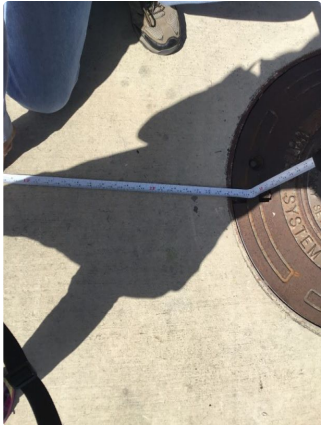
OWNER	Utility	TxDOT	Corridor	NOGALITOS	SITE PHOTOS
	Contact	SUMAN SHRESTHA	ID	4012	
GENERAL INFO	Utility	STORM SEWER			
	Size and Material	STANDARD MANHOLE, CAST IRON			
	Accessible Route	ASSET IS INSIDE ACCESSIBLE ROUTE			
	Longitudinal or Crossing	CROSSING			
	Placement Relative to ROW	INSIDE ROW			
LOCATION	Sheet No.				
	Station	107+41.17			
	Offset	-26.126			
	Latitude	+29.387741			
	Longitude	-98.52279			
SUE	Level of Investigation Req'd	NONE			
	Test Hole No	N/A			
	Test Hole Depth	N/A			
RESOLUTION	Recommended Action	NO CONFLICT			
	Estimated Resolution Date	8/13/2018			
	Resolution Status	NO RESOLUTION WAS REQUIRED			
	Comment	Unable to open manhole Back of curb to manhole = 2'-8"			
Date Collected		7/2/2018 10:39:06 AM		Date Modified 8/14/2018 4:38:26 PM
