Utility Conflict Report

OWNER	Utility	SAWS	Corridor	SW MILITARY	SITE PHOTOS	
	Contact	ANN PECHE	ID	4087		
GENERAL INFO	Utility	WATER

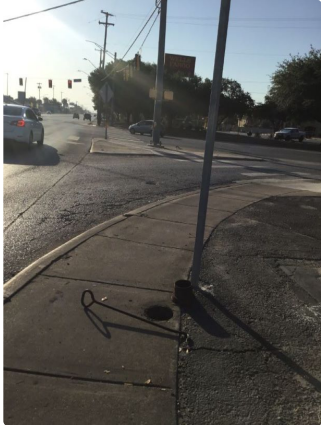
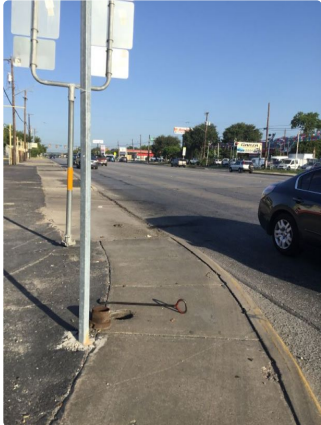
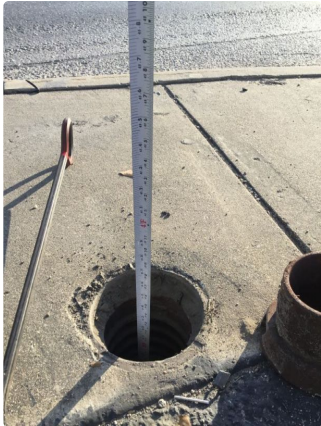
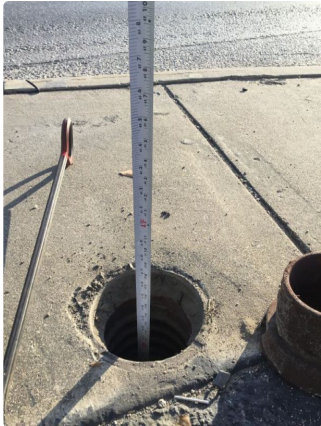
Size and Material	STANDARD WATER VALVE, CAST IRON				
	Accessible Route	ASSET IS INSIDE ACCESSIBLE ROUTE				
	Longitudinal or Crossing	CROSSING				
	Placement Relative to ROW	INSIDE ROW				
LOCATION	Sheet No.	129

Comment	Lid thickness = 1.5" Top of valve to surface= 3'-4.5" Back of curb to valve = 3'-1.5" Sidewalk width = 4'-0" Adjacent to existing VIA bus stop				
Date Collected		7/23/2018 8:16:21 AM		Date Modified 11/28/2018 6:59:12 AM

Test Hole No	N/A				
	Test Hole Depth	N/A				
RESOLUTION	Recommended Action	MINIMIZE - PROTECT IN PLACE
