## Utility Conflict Report

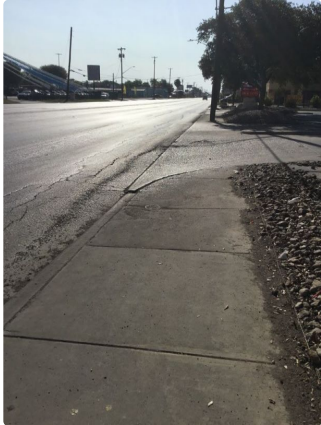
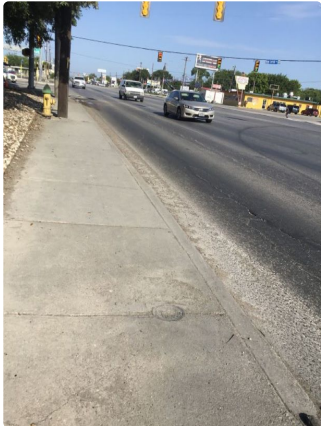
<b>OWNER</b>	<b>Utility</b>	SAWS	<b>Corridor</b>	SW MILITARY	<b>SITE PHOTOS</b>		
	<b>Contact</b>	ANN PECHE	<b>ID</b>	4094			
<b>GENERAL INFO</b>	<b>Utility</b>	WATER					
	<b>Size and Material</b>	STANDARD WATER VALVE, CAST IRON					
	<b>Accessible Route</b>	ASSET IS INSIDE ACCESSIBLE ROUTE					
	<b>Longitudinal or Crossing</b>	CROSSING					
	<b>Placement Relative to ROW</b>	INSIDE ROW					
<b>LOCATION</b>	<b>Sheet No.</b>						
	<b>Station</b>	534+22.65					
	<b>Offset</b>	13.91					
	<b>Latitude</b>	+29.358170					
	<b>Longitude</b>	-98.55897					
<b>SUE</b>	<b>Level of Investigation Req'd</b>	NONE					
	<b>Test Hole No</b>	N/A					
	<b>Test Hole Depth</b>	N/A					
<b>RESOLUTION</b>	<b>Recommended Action</b>	NO CONFLICT					
	<b>Estimated Resolution Date</b>	11/21/2018					
	<b>Resolution Status</b>	NO RESOLUTION WAS REQUIRED					
	<b>Comment</b>	Top of valve to surface = 5'-0" Sidewalk width = 6' Lid thickness = 2 1/8" Back of sidewalk to valve = 4'- 3" Back of curb to valve = 1'-0"
