## Utility Conflict Report

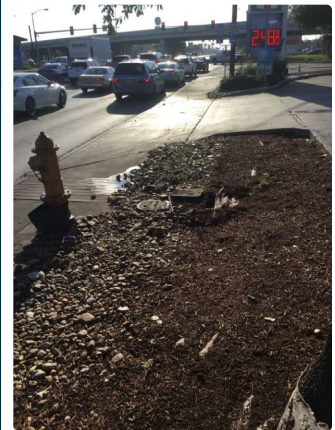
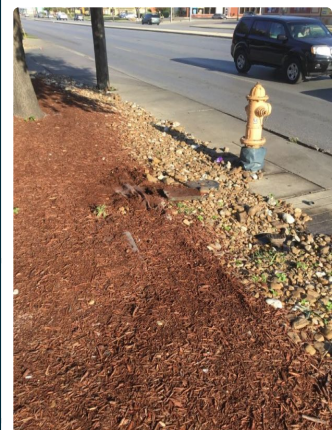
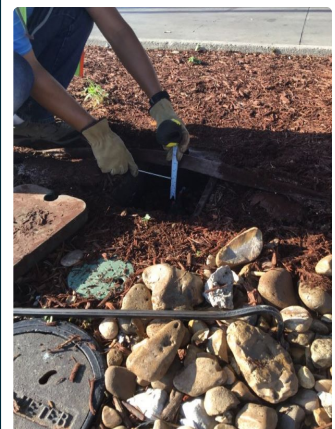
<b>OWNER</b>	<b>Utility</b>	SAWS	<b>Corridor</b>	SW MILITARY	<b>SITE PHOTOS</b>		
	<b>Contact</b>	ANN PECHE	<b>ID</b>	4134			
<b>GENERAL INFO</b>	<b>Utility</b>	WATER					
	<b>Size and Material</b>	STANDARD WATER METER, STEEL					
	<b>Accessible Route</b>	ASSET IS OUTSIDE ACCESSIBLE ROUTE					
	<b>Longitudinal or Crossing</b>	CROSSING					
	<b>Placement Relative to ROW</b>	INSIDE ROW					
<b>LOCATION</b>	<b>Sheet No.</b>	148					
	<b>Station</b>	636+56.33					
	<b>Offset</b>	22.6012					
	<b>Latitude</b>	+29.356583					
	<b>Longitude</b>	-98.52701					
<b>SUE</b>	<b>Level of Investigation Req'd</b>	NONE					
	<b>Test Hole No</b>	N/A					
	<b>Test Hole Depth</b>	N/A					
<b>RESOLUTION</b>	<b>Recommended Action</b>	NO CONFLICT					
	<b>Estimated Resolution Date</b>						
	<b>Resolution Status</b>	NO RESOLUTION WAS REQUIRED					
	<b>Comment</b>	Valve to back of sidewalk = 3'-7" Top of valve to surface = 4" Lid thickness = 1 5/8" Plastic lid
