Utility Conflict Report

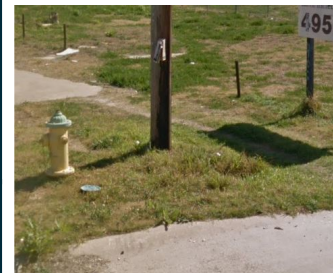
OWNER	Utility	CPS	Corridor	SW MILITARY	SITE PHOTOS
	Contact	BILL FEY	ID	4588	
GENERAL INFO	Utility	GAS			
	Size and Material	STANDARD GAS VALVE, CAST IRON			
	Accessible Route	ASSET IS INSIDE ACCESSIBLE ROUTE			
	Longitudinal or Crossing	CROSSING			
	Placement Relative to ROW	INSIDE ROW			
LOCATION	Sheet No.				
	Station	506+52.11			
	Offset	31.8574			
	Latitude	+29.358935			
	Longitude	-98.567647			
SUE	Level of Investigation Req'd	NONE			
	Test Hole No	N/A			
	Test Hole Depth	N/A			
RESOLUTION	Recommended Action	MINIMIZE - PROTECT IN PLACE			
	Estimated Resolution Date				
	Resolution Status	UTILITY OWNER INFORMED OF UTILITY			
	Comment				
Date Collected		12/17/2018 10:50:58 AM	Date Modified		12/17/2018 11:19:10 AM
