Utility Conflict Report

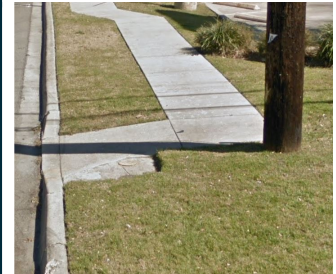
OWNER	Utility	CPS	Corridor	BANDERA	SITE PHOTOS
	Contact	BILL FEY	ID	4614	
GENERAL INFO	Utility	GAS			
	Size and Material	STANDARD GAS VALVE, CAST IRON			
	Accessible Route	ASSET IS OUTSIDE ACCESSIBLE ROUTE			
	Longitudinal or Crossing	CROSSING			
	Placement Relative to ROW	INSIDE ROW			
LOCATION	Sheet No.	249			
	Station	1483+46.48			
	Offset	51.66			
	Latitude	+29.519270			
	Longitude	-98.636907			
SUE	Level of Investigation Req'd	NONE			
	Test Hole No	N/A			
	Test Hole Depth	N/A			
RESOLUTION	Recommended Action	MINIMIZE - PROTECT IN PLACE			
	Estimated Resolution Date				
	Resolution Status	UTILITY OWNER INFORMED OF UTILITY			
	Comment				
Date Collected		12/18/2018 2:29:38 PM	Date Modified		12/19/2018 11:48:22 AM
