## Utility Conflict Report

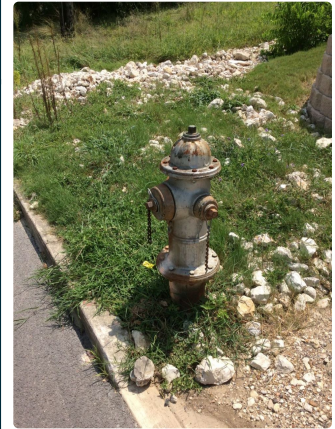
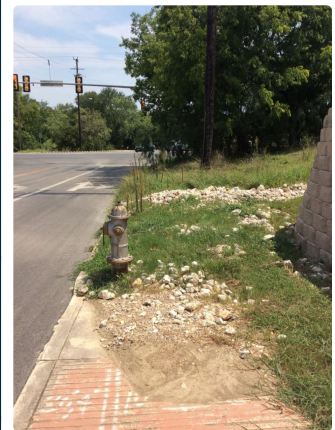
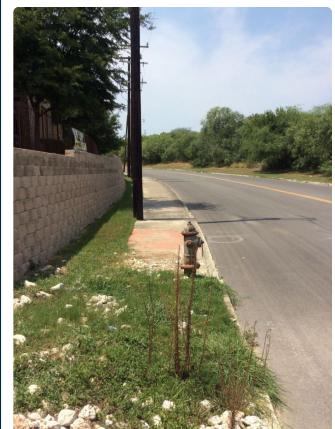
<b>OWNER</b>	<b>Utility</b>	SAWS	<b>Corridor</b>	MILITARY	<b>SITE PHOTOS</b>
	<b>Contact</b>	ANN PECHE	<b>ID</b>	7019	
<b>GENERAL INFO</b>	<b>Utility</b>	WATER			
	<b>Size and Material</b>	STANDARD FIRE HYDRANT			
	<b>Accessible Route</b>	ASSET IS INSIDE ACCESSIBLE ROUTE			
	<b>Longitudinal or Crossing</b>	CROSSING			
	<b>Placement Relative to ROW</b>	INSIDE ROW			
<b>LOCATION</b>	<b>Sheet No.</b>	224			
	<b>Station</b>	1284+68.68			
	<b>Offset</b>	-125.5468			
	<b>Latitude</b>	+29.356748			
	<b>Longitude</b>	-98.41536			
<b>SUE</b>	<b>Level of Investigation Req'd</b>	NONE			
	<b>Test Hole No</b>	N/A			
	<b>Test Hole Depth</b>	N/A			
<b>RESOLUTION</b>	<b>Recommended Action</b>	NO CONFLICT			
	<b>Estimated Resolution Date</b>	8/13/2018			
	<b>Resolution Status</b>	NO RESOLUTION WAS REQUIRED			
	<b>Comment</b>	Back of curb to hydrant = 11"			
<b>Date Collected</b>		8/2/2018 2:55:44 PM	<b>Date Modified</b>		11/28/2018 6:59:12 AM
