## Utility Conflict Report

<b>OWNER</b>	<b>Utility</b>	SAWS	<b>Corridor</b>	SW MILITARY	<div style="border: 1px solid black; padding: 5px; margin-bottom: 5px;"><b>SITE PHOTOS</b></div>

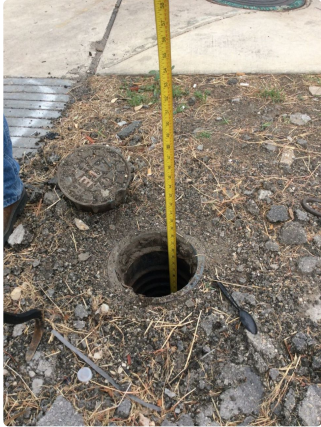
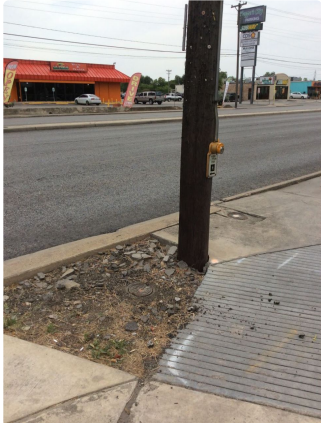
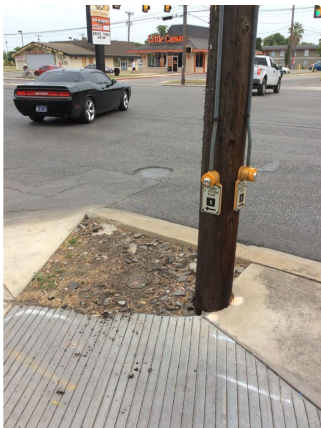
<b>Contact</b>	ANN PECHE	<b>ID</b>	7021	
<b>GENERAL INFO</b>	<b>Utility</b>	WATER			
	<b>Size and Material</b>	STANDARD WATER VALVE, CAST IRON			
	<b>Accessible Route</b>	ASSET IS OUTSIDE ACCESSIBLE ROUTE			
	<b>Longitudinal or Crossing</b>	CROSSING			
	<b>Placement Relative to ROW</b>	INSIDE ROW			
<b>LOCATION</b>	<b>Sheet No.</b>	213			
	<b>Station</b>	955+29.01			
	<b>Offset</b>	-18.0961			
	<b>Latitude</b>	+29.356864			
	<b>Longitude</b>	-98.49908			
<b>SUE</b>	<b>Level of Investigation Req'd</b>	NONE			
	<b>Test Hole No</b>	N/A			
	<b>Test Hole Depth</b>	N/A			
<b>RESOLUTION</b>	<b>Recommended Action</b>	MINIMIZE - PROTECT IN PLACE			
	<b>Estimated Resolution Date</b>				
	<b>Resolution Status</b>	UTILITY OWNER INFORMED OF UTILITY

<b>Comment</b>	Top of valve to bottom of lid = 3'-0" Back of curb to valve = 1'-11" Valve to pole = 1'-5"			
<b>Date Collected</b>		8/2/2018 4:11:31 PM	<b>Date Modified</b>		12/18/2018 8:52:41 AM
