## Utility Conflict Report

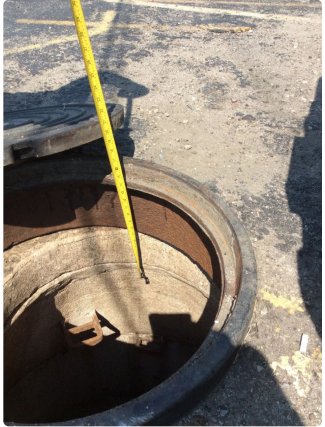
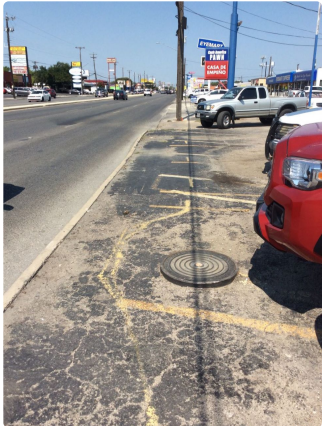
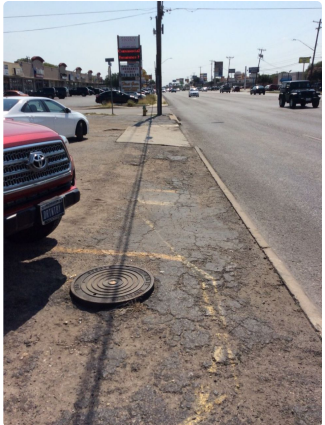
<b>OWNER</b>	<b>Utility</b>	SAWS	<b>Corridor</b>	SW MILITARY	<b>SITE PHOTOS</b>
	<b>Contact</b>	ANN PECHE	<b>ID</b>	7058	
<b>GENERAL INFO</b>	<b>Utility</b>	SANITARY SEWER			
	<b>Size and Material</b>	STANDARD MANHOLE, CAST IRON			
	<b>Accessible Route</b>	ASSET IS INSIDE ACCESSIBLE ROUTE			
	<b>Longitudinal or Crossing</b>	CROSSING			
	<b>Placement Relative to ROW</b>	INSIDE ROW			
<b>LOCATION</b>	<b>Sheet No.</b>	204			
	<b>Station</b>	911+33.60			
	<b>Offset</b>	-18.3287			
	<b>Latitude</b>	+29.356839			
	<b>Longitude</b>	-98.51284			
<b>SUE</b>	<b>Level of Investigation Req'd</b>	NONE			
	<b>Test Hole No</b>	N/A			
	<b>Test Hole Depth</b>	N/A			
<b>RESOLUTION</b>	<b>Recommended Action</b>	NO CONFLICT			
	<b>Estimated Resolution Date</b>				
	<b>Resolution Status</b>	NO RESOLUTION WAS REQUIRED			
	<b>Comment</b>	Top of cone to bottom of lid = 1'-1" Back of curb to manhole = 3'-7"			
<b>Date Collected</b>		8/3/2018 11:01:25 AM		<b>Date Modified</b> 11/28/2018 6:59:12 AM
