Utility Conflict Report

OWNER	Utility	SAWS	Corridor	SW MILITARY	SITE PHOTOS	
	Contact	ANN PECHE	ID	7076		
GENERAL INFO	Utility	WATER

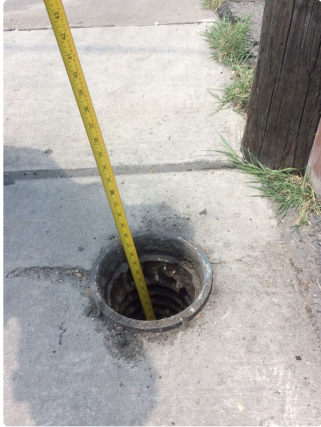
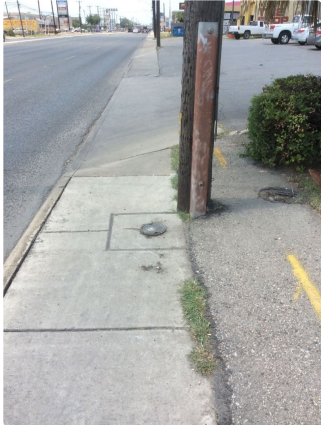
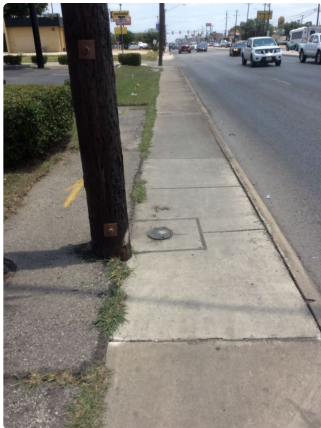
Size and Material	STANDARD WATER VALVE, CAST IRON				
	Accessible Route	ASSET IS INSIDE ACCESSIBLE ROUTE				
	Longitudinal or Crossing	CROSSING				
	Placement Relative to ROW	INSIDE ROW				
LOCATION	Sheet No.	202

Station	894+04.50				
	Offset	-16.43				
	Latitude	+29.356833				
	Longitude	-98.51833				
SUE	Level of Investigation Req'd	NONE

Test Hole No	N/A				
	Test Hole Depth	N/A				
RESOLUTION	Recommended Action	MINIMIZE - PROTECT IN PLACE				
	Estimated Resolution Date					
	Resolution Status	UTILITY OWNER INFORMED OF UTILITY				
	Comment	Back of curb to valve = 2'-9" Top of valve to surface = 2'-3" Lid thickness = 2"				
Date Collected		8/3/2018 1:27:32 PM	Date Modified		11/28/2018 6:59:12 AM
