## Utility Conflict Report

<b>OWNER</b>	<b>Utility</b>	SAWS	<b>Corridor</b>	SW MILITARY	<b>SITE PHOTOS</b>	
	<b>Contact</b>	ANN PECHE	<b>ID</b>	7116		
<b>GENERAL INFO</b>	<b>Utility</b>	WATER

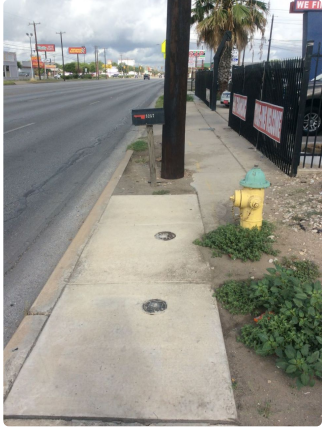
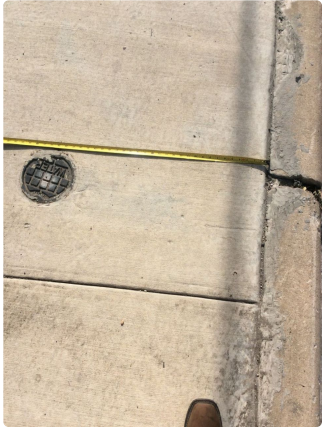
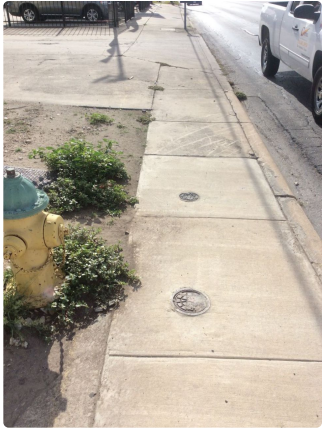
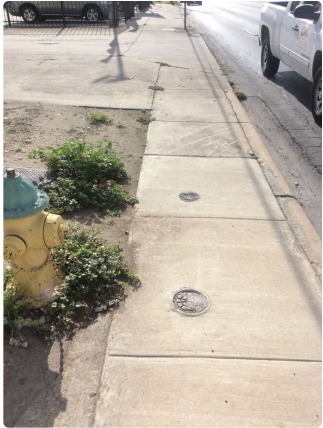
<b>Estimated Resolution Date</b>					
	<b>Resolution Status</b>	NO RESOLUTION WAS REQUIRED				
	<b>Comment</b>	2 water valves Unable to open both lids Back of curb to valve 1 = 2'-2" Back of curb to valve 2 = 2'-4"

<b>Test Hole No</b>	N/A				
	<b>Test Hole Depth</b>	N/A				
<b>RESOLUTION</b>	<b>Recommended Action</b>	NO CONFLICT
