## Utility Conflict Report

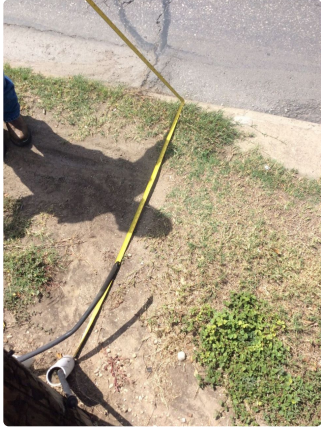
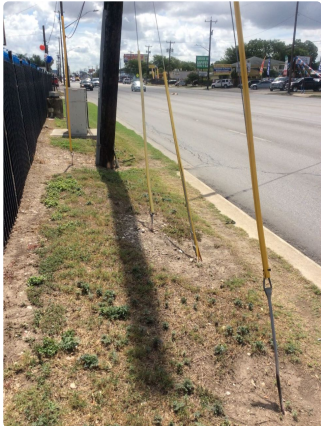
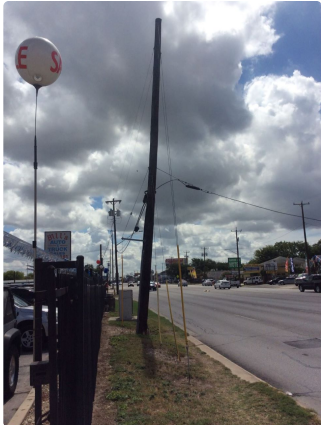
<b>OWNER</b>	<b>Utility</b>	CPS	<b>Corridor</b>	SW MILITARY	<b>SITE PHOTOS</b>
	<b>Contact</b>	JAKE MARTINEZ	<b>ID</b>	7139	
<b>GENERAL INFO</b>	<b>Utility</b>	ELECTRIC			
	<b>Size and Material</b>	STANDARD POWER POLE, TIMBER			
	<b>Accessible Route</b>	ASSET IS INSIDE ACCESSIBLE ROUTE			
	<b>Longitudinal or Crossing</b>	CROSSING			
	<b>Placement Relative to ROW</b>	INSIDE ROW			
<b>LOCATION</b>	<b>Sheet No.</b>	178			
	<b>Station</b>	766+54.91			
	<b>Offset</b>	-18.16			
	<b>Latitude</b>	+29.358335			
	<b>Longitude</b>	-98.55830			
<b>SUE</b>	<b>Level of Investigation Req'd</b>	NONE			
	<b>Test Hole No</b>	N/A			
	<b>Test Hole Depth</b>	N/A			
<b>RESOLUTION</b>	<b>Recommended Action</b>	NO CONFLICT			
	<b>Estimated Resolution Date</b>				
	<b>Resolution Status</b>	NO RESOLUTION WAS REQUIRED			
	<b>Comment</b>	Back of curb to pole = 4'-5" Pole diameter = 12" No pole ID Fence to pole = 3'-11" Underground cables 4 guy wires Pole to guy wire 1 (behind pole) = 1'-10" Pole to guy wire 2 (west of pole) = 13'-2" Fence to guy wire 1 (behind pole) = 5'-0"
