## Utility Conflict Report

<b>OWNER</b>	<b>Utility</b>	SAWS	<b>Corridor</b>	SW MILITARY	<b>SITE PHOTOS</b>		
	<b>Contact</b>	ANN PECHE	<b>ID</b>	7142			
<b>GENERAL INFO</b>	<b>Utility</b>	WATER

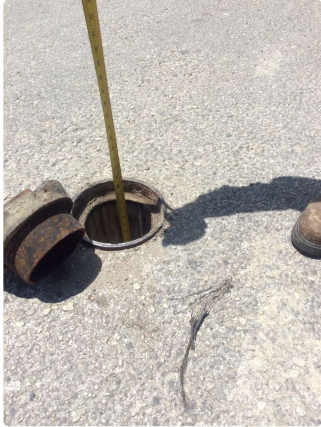
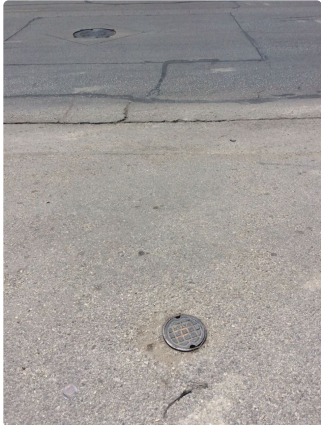
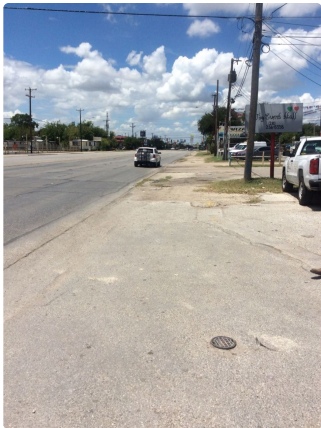
<b>Size and Material</b>	STANDARD WATER VALVE, CAST IRON					
	<b>Accessible Route</b>	ASSET IS INSIDE ACCESSIBLE ROUTE					
	<b>Longitudinal or Crossing</b>	CROSSING					
	<b>Placement Relative to ROW</b>	INSIDE ROW					
<b>LOCATION</b>	<b>Sheet No.</b>	177

<b>Test Hole No</b>	N/A					
	<b>Test Hole Depth</b>	N/A					
<b>RESOLUTION</b>	<b>Recommended Action</b>	NO CONFLICT					
	<b>Estimated Resolution Date</b>						
	<b>Resolution Status</b>	NO RESOLUTION WAS REQUIRED					
	<b>Comment</b>	Top of valve to surface = 3'-10" Lid thickness = 1.5" Edge of pavement to valve = 9'-4"
