## Utility Conflict Report

| <b>OWNER</b> | <b>Utility</b> | CPS | <b>Corridor</b> | NOGALITOS | <b>SITE PHOTOS</b> |
| | <b>Contact</b> | JAKE MARTINEZ | <b>ID</b> | 3051 | |

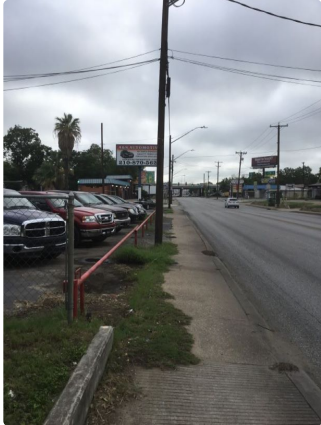
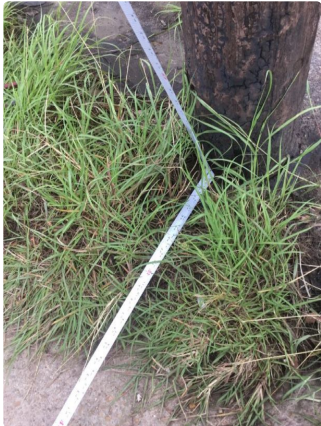
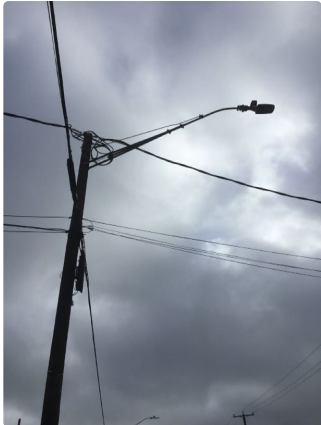
| | <b>Size and Material</b> | STANDARD POWER POLE, TIMBER | | | |
| | <b>Accessible Route</b> | ASSET IS OUTSIDE ACCESSIBLE ROUTE | | | |
| | <b>Comment</b> | Pole ID: LW 43331; PL 414115<br>Pole marking: 1915<br>Pole to back of curb = 4'-11"<br>Pole to back of sidewalk = 11"<br>Sidewalk width = 4'-0"<br>Pole to fence = 1'-10" | | | |

| <b>RESOLUTION</b> | <b>Recommended Action</b> | NO CONFLICT | | | |
| | <b>Resolution Status</b> | NO RESOLUTION WAS REQUIRED | | | |
