## Utility Conflict Report

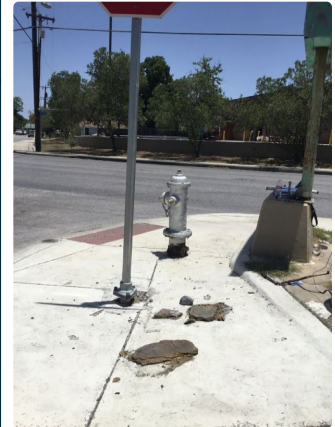
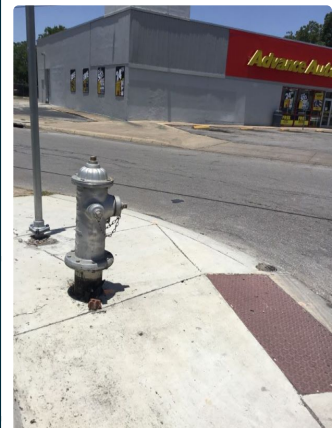
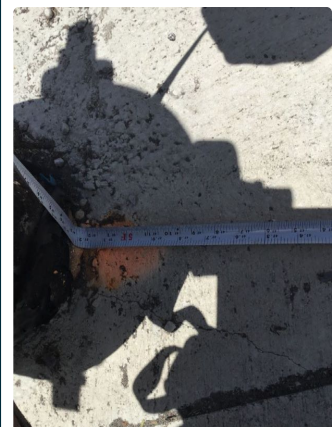
<b>OWNER</b>	<b>Utility</b>	SAWS	<b>Corridor</b>	NOGALITOS	<b>SITE PHOTOS</b>
	<b>Contact</b>	NINA BITTLE	<b>ID</b>	4023	
<b>GENERAL INFO</b>	<b>Utility</b>	WATER			
	<b>Size and Material</b>	STANDARD FIRE HYDRANT			
	<b>Accessible Route</b>	ASSET IS INSIDE ACCESSIBLE ROUTE			
	<b>Longitudinal or Crossing</b>	CROSSING			
	<b>Placement Relative to ROW</b>	INSIDE ROW			
<b>LOCATION</b>	<b>Sheet No.</b>				
	<b>Station</b>	111+29.08			
	<b>Offset</b>	-32.8894			
	<b>Latitude</b>	+29.388644			
	<b>Longitude</b>	-98.52220			
<b>SUE</b>	<b>Level of Investigation Req'd</b>	NONE			
	<b>Test Hole No</b>	N/A			
	<b>Test Hole Depth</b>	N/A			
<b>RESOLUTION</b>	<b>Recommended Action</b>	NO CONFLICT			
	<b>Estimated Resolution Date</b>	8/13/2018			
	<b>Resolution Status</b>	NO RESOLUTION WAS REQUIRED			
	<b>Comment</b>	Hydrant to face of wall = 5'-2" Hydrant to face of curb = 1'-10"			
<b>Date Collected</b>		7/2/2018 1:41:04 PM		<b>Date Modified</b> 8/14/2018 4:38:26 PM
