Utility Conflict Report

OWNER	Utility	SAWS	Corridor	NOGALITOS	SITE PHOTOS	
	Contact	ANN PECHE	ID	4025		
GENERAL INFO	Utility	WATER

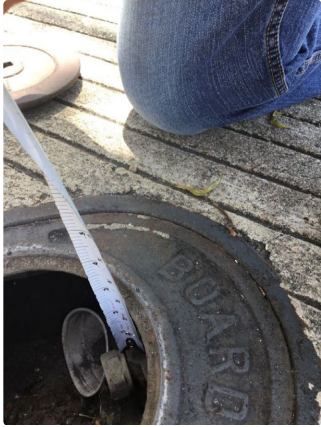
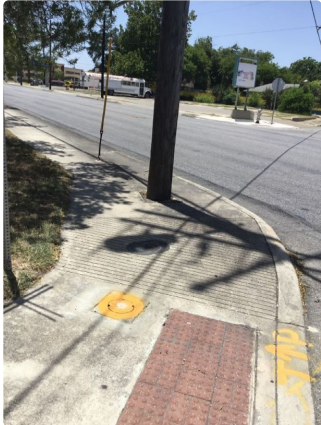
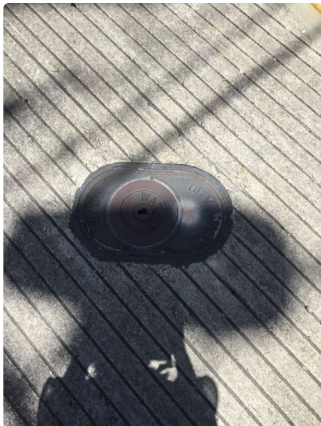
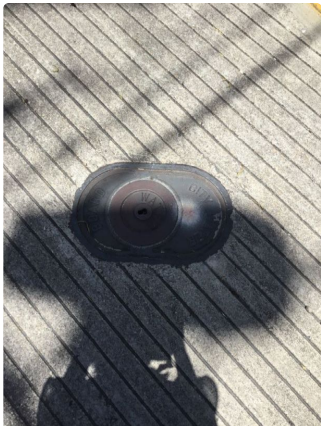
Size and Material	STANDARD WATER VALVE, CAST IRON				
	Accessible Route	ASSET IS INSIDE ACCESSIBLE ROUTE				
	Longitudinal or Crossing	CROSSING				
	Placement Relative to ROW	INSIDE ROW				
LOCATION	Sheet No.	113

Comment	Top of valve to surface = 2.8" Lid thickness = 3/8" Back of curb to valve = 3'4" Lower underlying asset, not enough vertical clearance inside valve box to lower 3-4" needed				
Date Collected		7/2/2018 1:55:22 PM		Date Modified	10/12/2018 3:14:06 PM

Test Hole No	N/A				
	Test Hole Depth	N/A				
RESOLUTION	Recommended Action	MINIMIZE - PROTECT IN PLACE
