## Utility Conflict Report

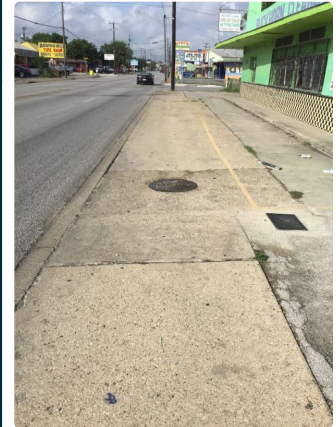
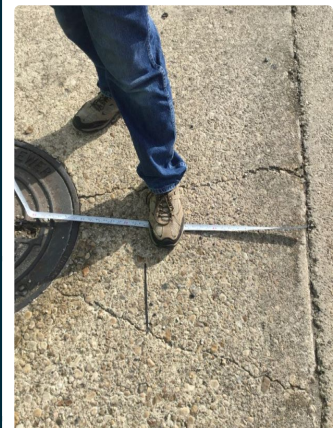
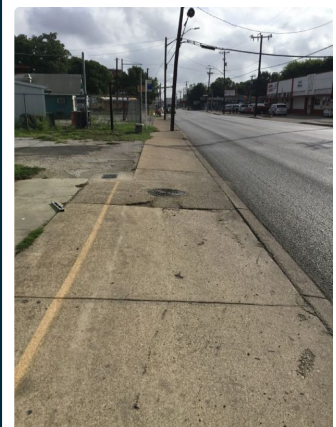
<b>OWNER</b>	<b>Utility</b>	SAWS	<b>Corridor</b>	NOGALITOS	<b>SITE PHOTOS</b>		
	<b>Contact</b>	ANN PECHE	<b>ID</b>	4058			
<b>GENERAL INFO</b>	<b>Utility</b>	SANITARY SEWER					
	<b>Size and Material</b>	STANDARD MANHOLE, CAST IRON					
	<b>Accessible Route</b>	ASSET IS INSIDE ACCESSIBLE ROUTE					
	<b>Longitudinal or Crossing</b>	CROSSING					
	<b>Placement Relative to ROW</b>	INSIDE ROW					
<b>LOCATION</b>	<b>Sheet No.</b>	120					
	<b>Station</b>	123+32.82					
	<b>Offset</b>	-26.4					
	<b>Latitude</b>	+29.391302					
	<b>Longitude</b>	-98.51975					
<b>SUE</b>	<b>Level of Investigation Req'd</b>	NONE					
	<b>Test Hole No</b>	N/A					
	<b>Test Hole Depth</b>	N/A					
<b>RESOLUTION</b>	<b>Recommended Action</b>	MINIMIZE - PROTECT IN PLACE					
	<b>Estimated Resolution Date</b>						
	<b>Resolution Status</b>	UTILITY OWNER INFORMED OF UTILITY					
	<b>Comment</b>	Unable to open manhole Manhole to back of curb = 2'-6" Sidewalk width = 6'-2" Lower rim 1"
