**PUBLIC LIBRARY  
700 E. Common Street  
New Braunfels, TX 78130**

## **ADA SELF-EVALUATION FACILITY SURVEY**

# New Braunfels Public Library

Jun 29, 2021

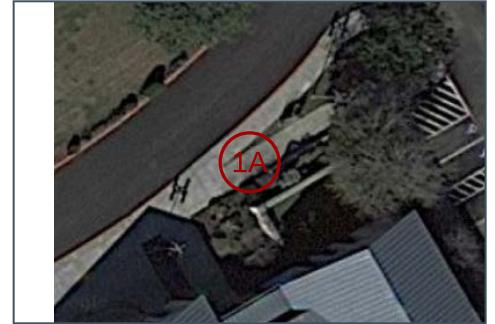
C3

Sidewalk has a 1" gap between panels.

Recommendation: Fill gap with caulking material.

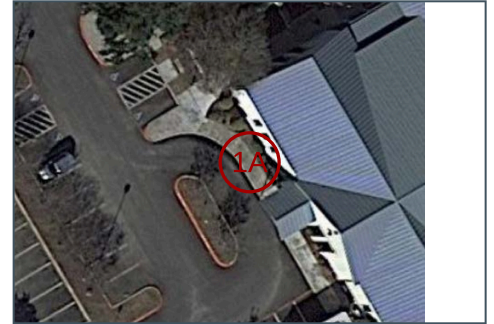
C2

The sidewalk has a cross slope of to 4.6% and changes in level of up to 1-3/4" in two locations.

Recommendation: Remove and replace length of sidewalk. (4panels, 132 SF)

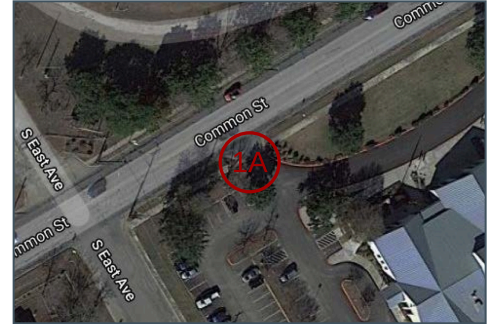
C1

The route connecting to the public sidewalk has a cross slope of approximately 2.5%.

Note: Due to the relatively low severity of the issue, this correction may be considered low priority.

Recommendation: Remove and replace sidewalk. (25 SF)

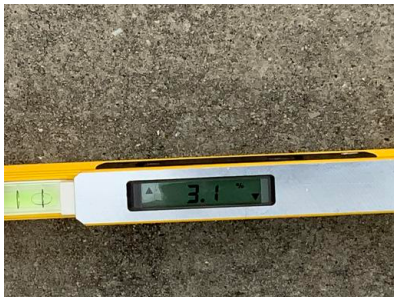
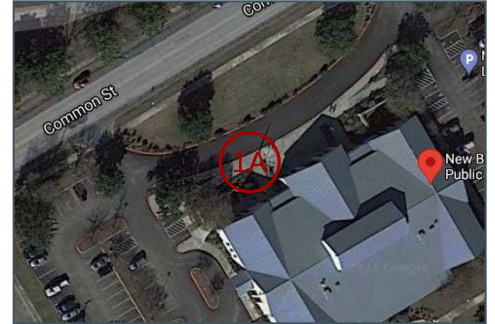
C1

The sidewalk has a cross slope of approximately 3.1%.

Recommendation: Remove and replace sidewalk. (1 large panel, 120 SF)

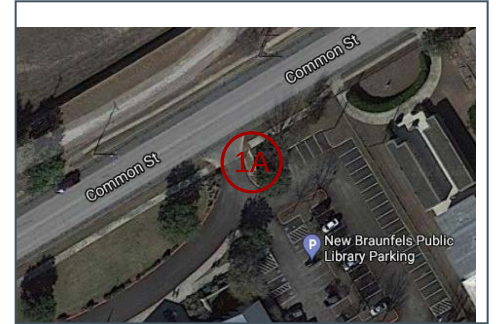
C1

The route connecting to the  
public sidewalk has a cross  
slope of approximately 7.5%.

Recommendation: Remove  
and replace sidewalk. (25  
SF)

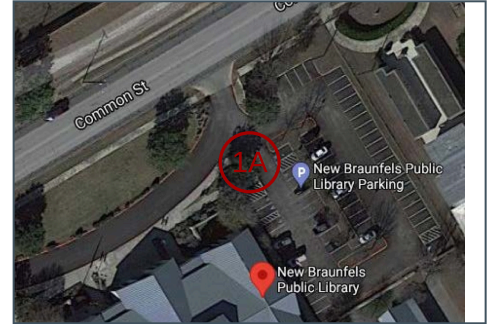
C1

The sidewalk around the tree  
has a cross slope of up to  
3.1%.

Recommendation: Remove  
and replace sidewalk.  
(2 panels, 96 SF)

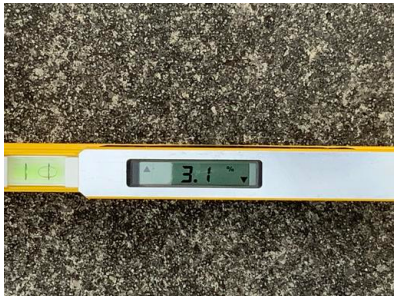
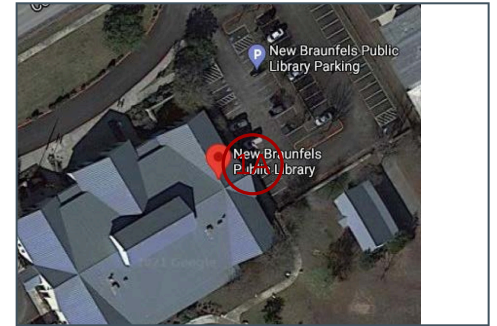
C1

A portion of sidewalk leading to the reading garden has a cross slope of approximately 3.1%.

Recommendation: Remove and replace sidewalk. (One panel, 42 SF)

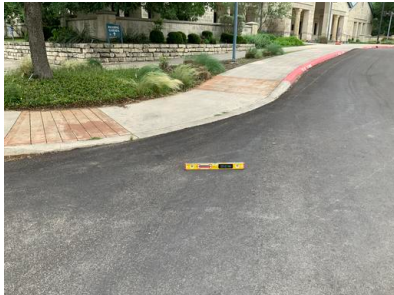
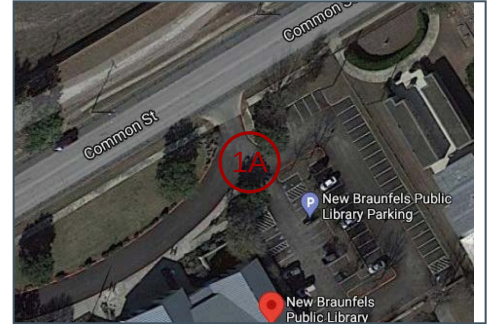
C1

The accessible route from the public sidewalk across the east drive way has a cross slope of approximately 3.3%.

Recommendation: Replace asphalt along this route. (100 SF)

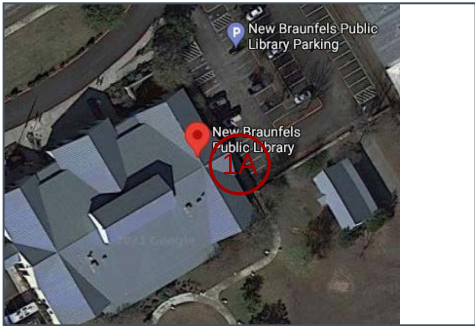
Sheet  
C1

Description  
A portion of sidewalk leading to the reading garden has a 1/2" abrupt change in level.

Recommendation: Grind edge to a maximum 1:2 bevel.

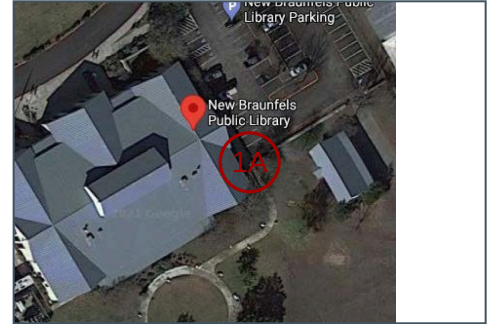
C1

The sidewalk has a 1/2" abrupt change in level between panels.

Recommendation: Grind edge to a maximum 1:2 slope.

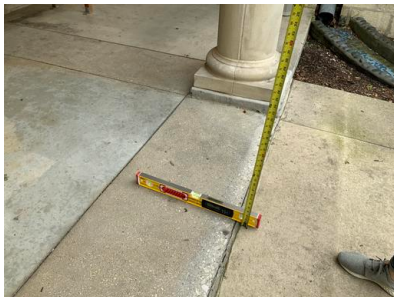
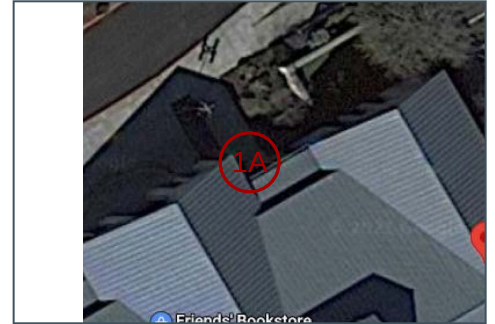
C3

Route has an approximate 1/2" abrupt change in level at joint.

Recommendation: Grind edge to a maximum 1:2 bevel.

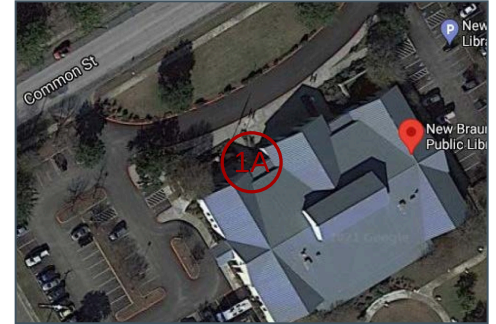
C1

Route has an approximate 1/2" abrupt change in level at joint.

Recommendation: Grind edge to a maximum 1:2 bevel.

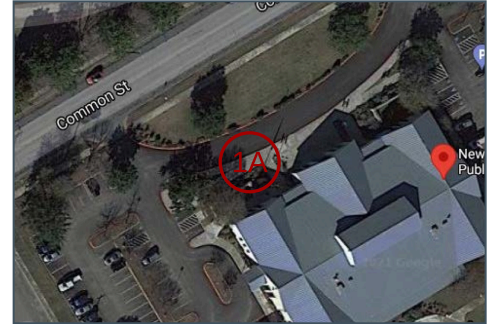
C1

Sidewalk has a 1" gap between panels.

Recommendation: Fill gap with caulking material.

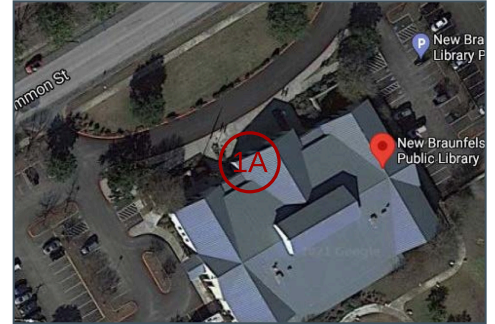
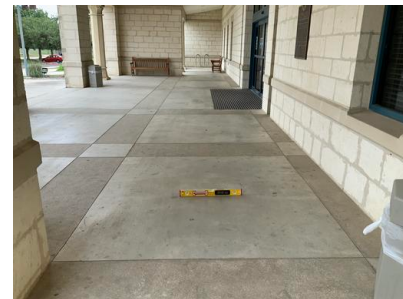
C1

The covered approach to the main entrance has a cross slope of up to 2.7%.

Note: Due to the relatively low severity of the issue, this correction may be considered low priority.

Recommendation: Remove and replace sidewalk. (2 large panels, 160 SF)

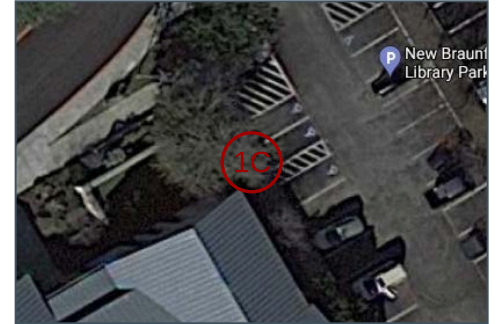
C3

The landing and both runs of the parallel curb ramp have a cross slope ranging from 3.2% to 4%.

Recommendation: Remove and replace curb ramp.

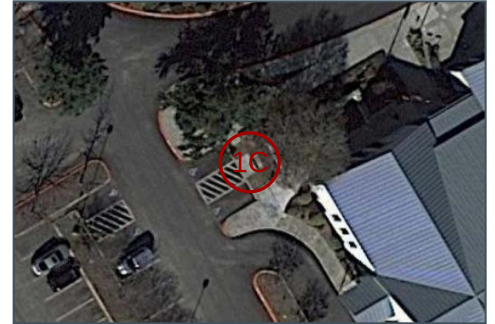
C2

The landing and both runs of the parallel curb ramp have a cross slope ranging from 3.1% to 4.9%.

Recommendation: Remove and replace curb ramp.

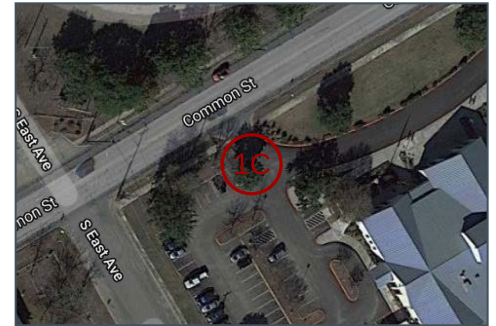
C1

The curb ramp at the west  
driveway has a cross slope  
of approximately 4.8%.

Recommendation: Remove  
and replace curb ramp.

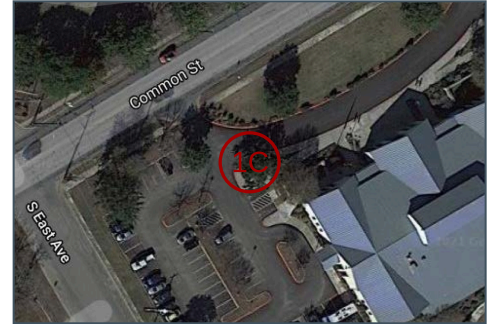
C1

The parallel curb ramp at the west end of the circle drive has running slopes of 9 and 9.7% on each side.

Recommendation: Remove and replace curb ramp.

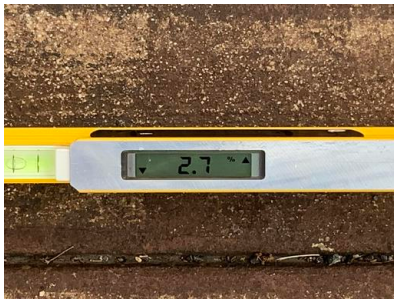
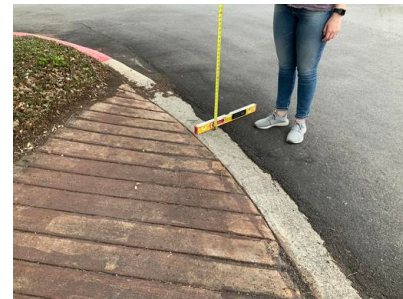
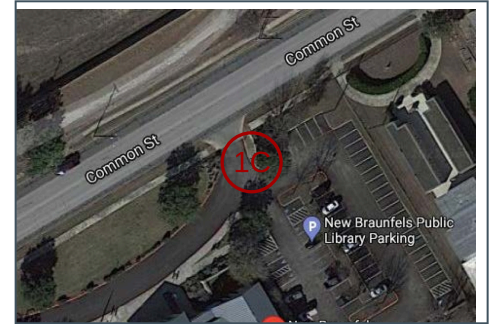
C1

The curb ramp at the east driveway has a cross slope of approximately 2.7% and a 3/4" change in level at the bottom.

Recommendation: Remove and replace curb ramp.

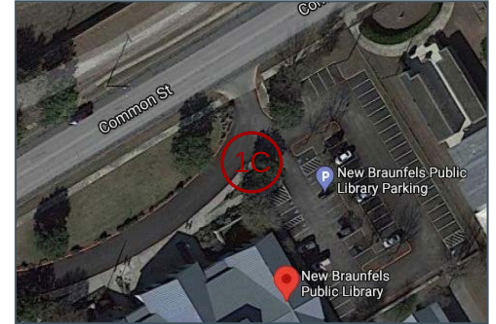
C1

The parallel curb ramp at the east end of the circle drive has excessive cross slopes on both runs and the landing and excessive running slopes on the right-hand run.

Recommendation: Remove and replace curb ramp.

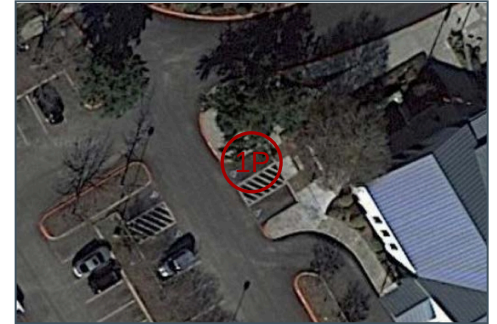
The northernmost accessible space has an uneven surface and a cross slope of approximately 2.8%.

Recommendation: Replace asphalt paving and restripe.
