San Antonio  
Wastewater  
Facilities  
Improvements

201 CATEGORY NO.5 DOWNTOWN PROJECT  
MANHOLE AND MAINLINE REHABILITATION  
"PLAN OF RECORD"

TWO-O-ONE CAT 5 SP-37  
(DOWNTOWN MAIN REHAB)

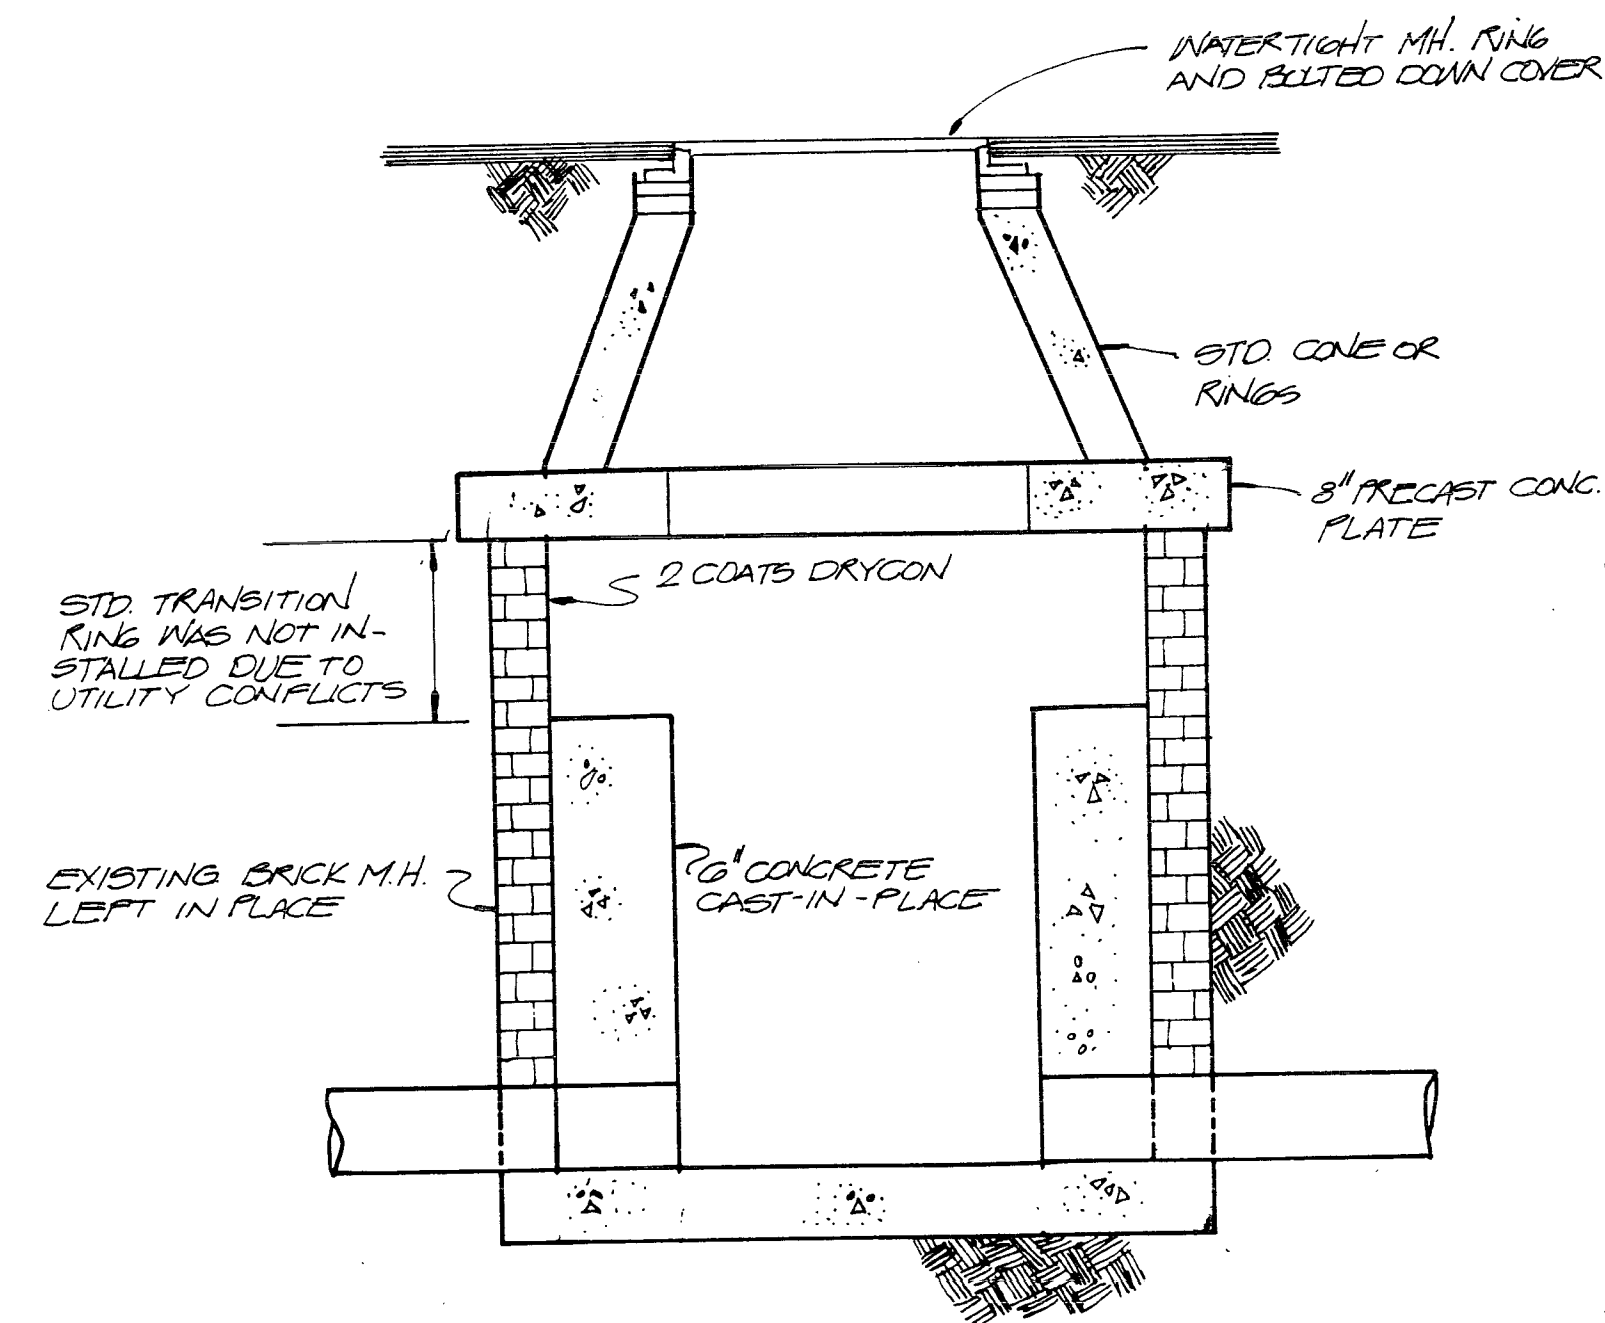
MODIFIED TOP

NOTE: ALL TOPS OF MANHOLES WERE CONCRETE  
ENCASED PER C.S.A. SPECIFICATIONS.

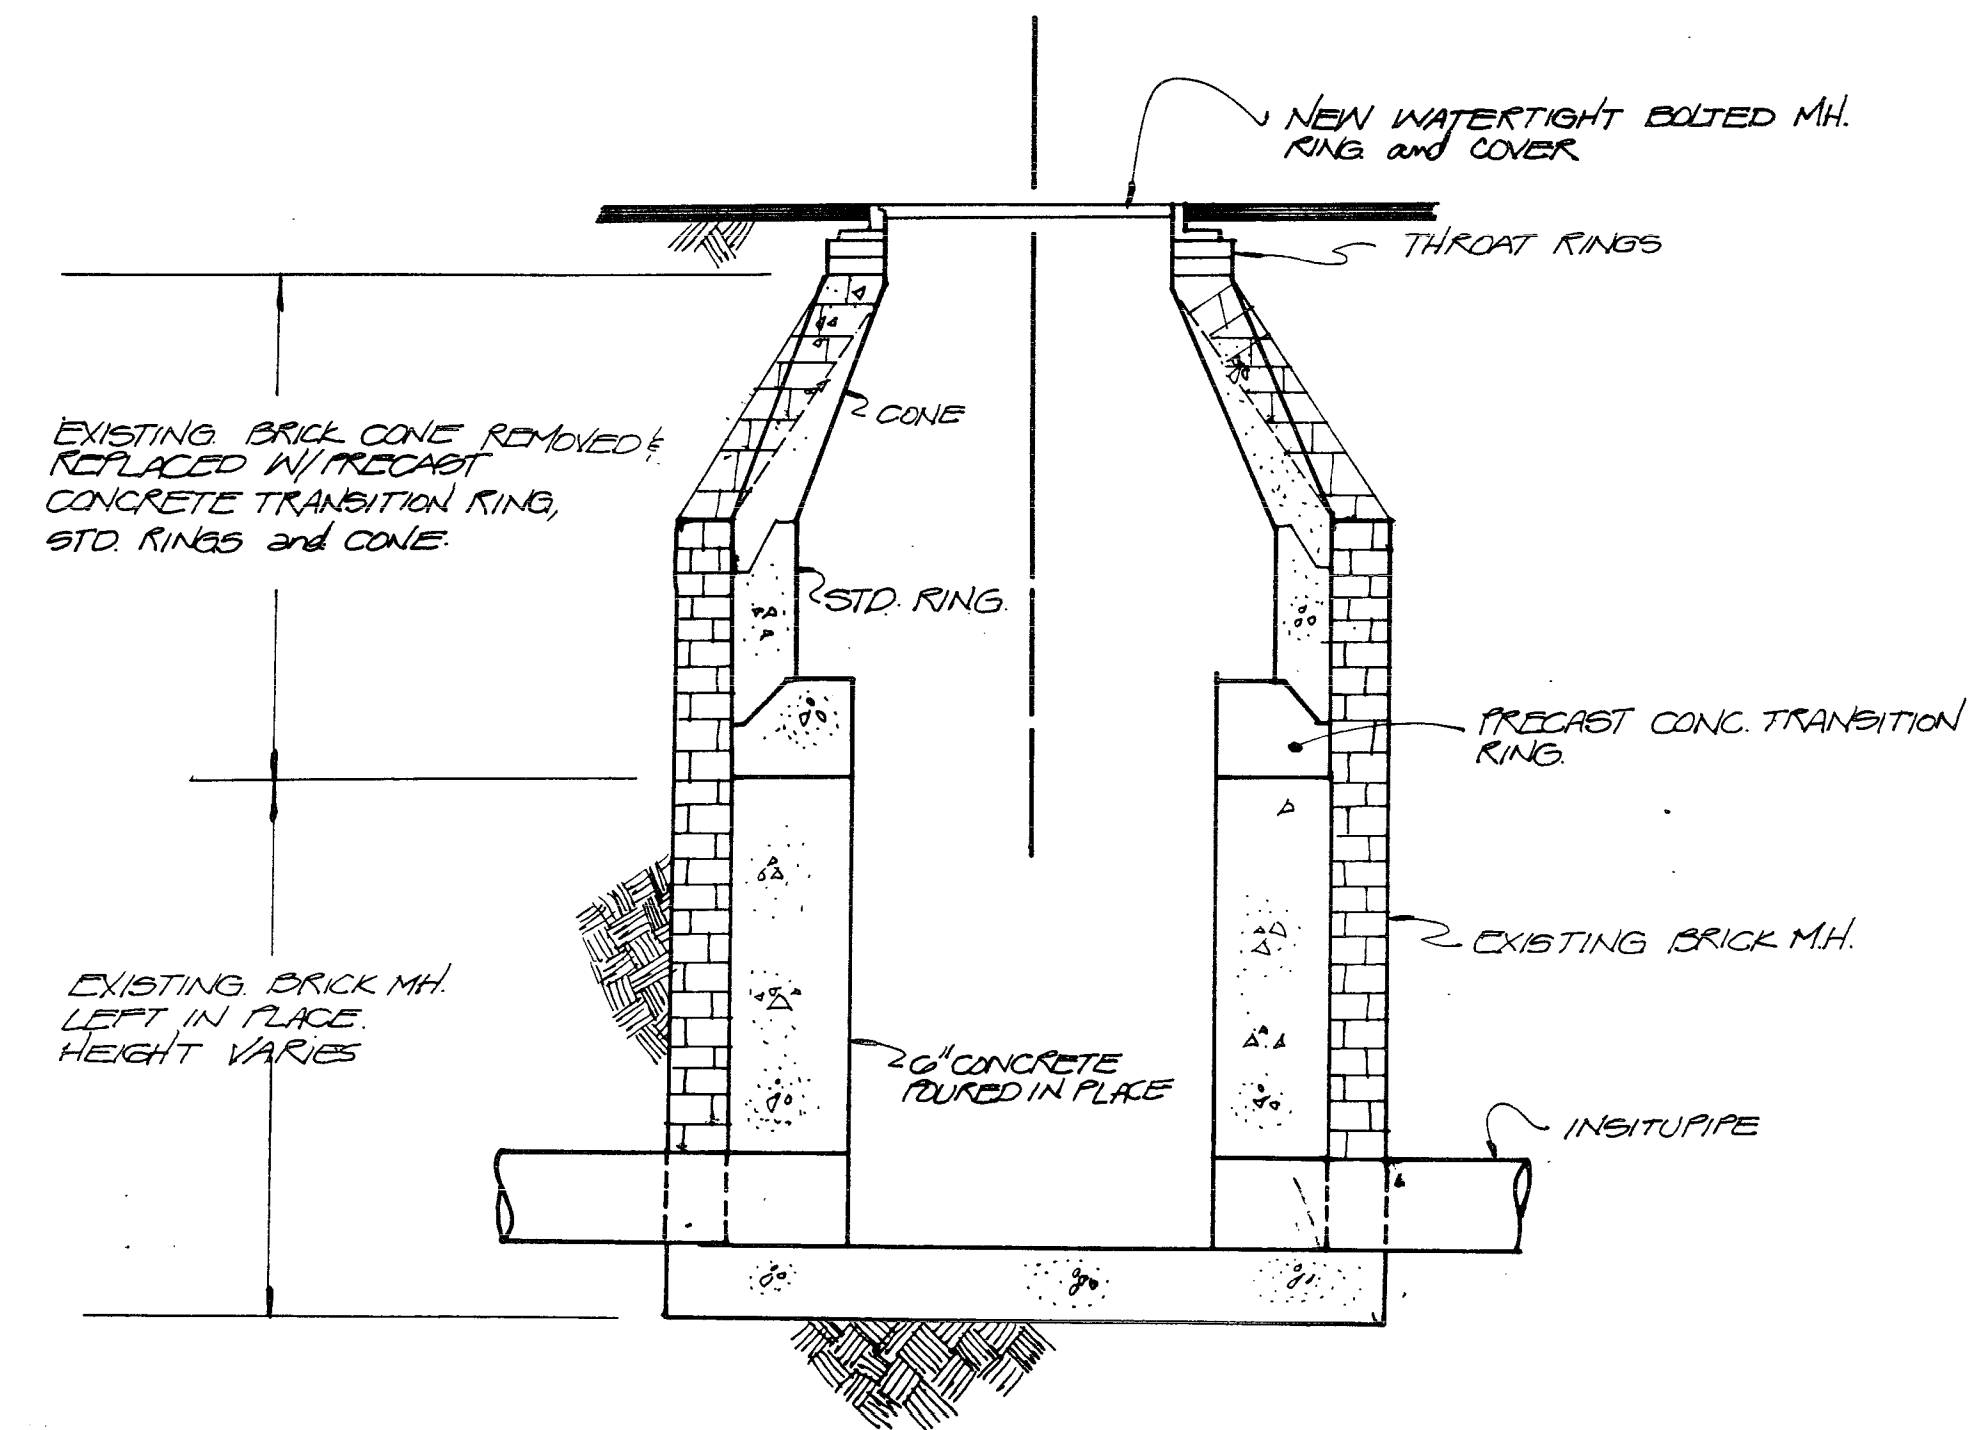
STANDARD REHABILITATION
