Utility Conflict Report

OWNER	Utility	SAWS	Corridor	NOGALITOS	SITE PHOTOS		
	Contact	NINA BITTLE	ID	3023			
GENERAL INFO	Utility	SANITARY SEWER

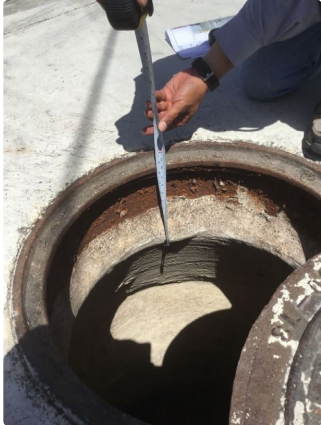
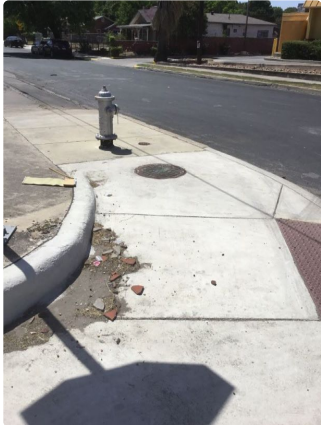
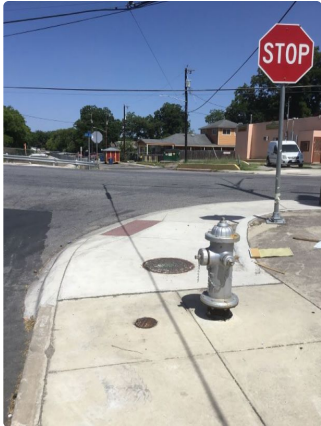
Size and Material	STANDARD MANHOLE, CAST IRON					
	Accessible Route	ASSET IS INSIDE ACCESSIBLE ROUTE					
	Longitudinal or Crossing	CROSSING					
	Placement Relative to ROW	INSIDE ROW					
LOCATION	Sheet No.

Station	114+75.48					
	Offset	-41.6481					
	Latitude	+29.389397					
	Longitude	-98.52146					
SUE	Level of Investigation Req'd	NONE

Test Hole No	N/A					
	Test Hole Depth	N/A					
RESOLUTION	Recommended Action	NO CONFLICT					
	Estimated Resolution Date	8/13/2018					
	Resolution Status	NO RESOLUTION WAS REQUIRED					
	Comment	Bottom of cone to surface = 11" Lid flange thickness = 1" Sidewalk width = 7'-4"					
Date Collected		7/2/2018 3:39:37 PM		Date Modified		8/14/2018 4:38:26 PM
