## Utility Conflict Report

<b>OWNER</b>	<b>Utility</b>	SAWS	<b>Corridor</b>	NOGALITOS	<b>SITE PHOTOS</b>		
	<b>Contact</b>	NINA BITTLE	<b>ID</b>	3033			
<b>GENERAL INFO</b>	<b>Utility</b>	WATER

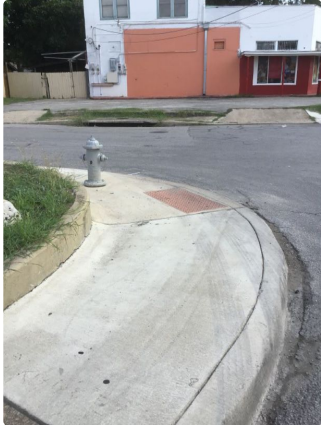
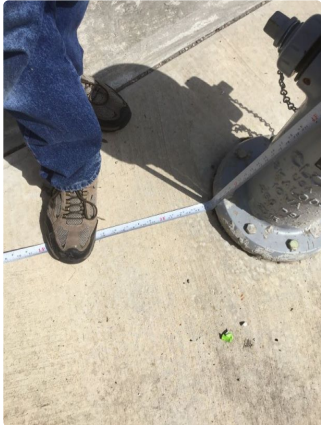
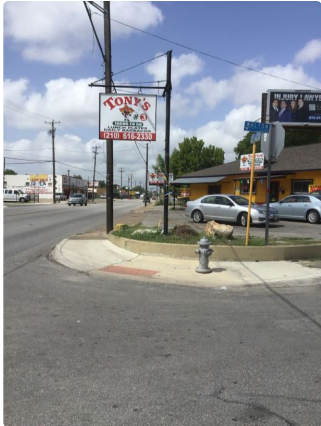
<b>Size and Material</b>	STANDARD FIRE HYDRANT					
	<b>Accessible Route</b>	ASSET IS INSIDE ACCESSIBLE ROUTE					
	<b>Longitudinal or Crossing</b>	CROSSING					
	<b>Placement Relative to ROW</b>	INSIDE ROW					
<b>LOCATION</b>	<b>Sheet No.</b>

<b>Test Hole No</b>	N/A					
	<b>Test Hole Depth</b>	N/A					
<b>RESOLUTION</b>	<b>Recommended Action</b>	NO CONFLICT					
	<b>Estimated Resolution Date</b>	8/13/2018					
	<b>Resolution Status</b>	NO RESOLUTION WAS REQUIRED					
	<b>Comment</b>	Hydrant to back of curb = 2'-3" Hydrant to face of wall = 2'-5 3/4". Sidewalk width (at hydrant) = 5'-9"
