## Utility Conflict Report

| <b>OWNER</b> | <b>Utility</b> | SAWS | <b>Corridor</b> | NOGALITOS | <b>SITE PHOTOS</b> | | |
| | <b>Contact</b> | ANN PECHE | <b>ID</b> | 3074 | | | |

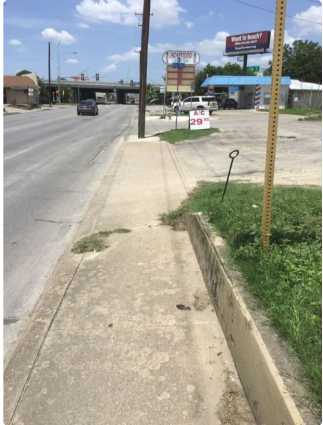
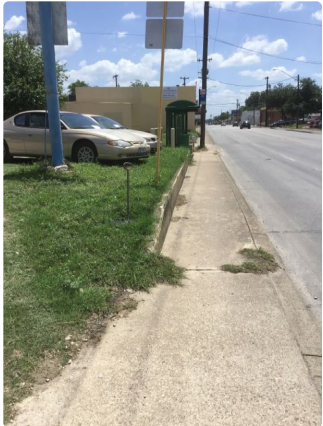
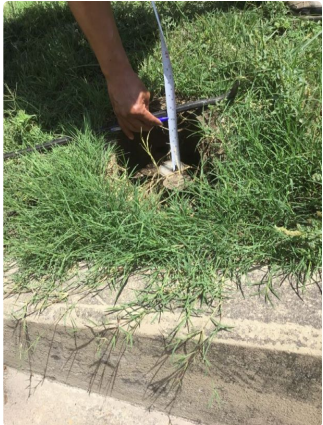
| | <b>Size and Material</b> | STANDARD WATER METER, STEEL | | | | | |
| <b>RESOLUTION</b> | <b>Recommended Action</b> | NO CONFLICT | | | | | |
| | <b>Comment</b> | Top of meter to surface = 6"<br>Rubber lid thickness = 2"<br>Face of wall to meter = 8"<br>Raise meter enclosure to top of wall (approx 4") | | | | | |
