## Utility Conflict Report

| <b>OWNER</b> | <b>Utility</b> | SAWS | <b>Corridor</b> | SW MILITARY | <b>SITE PHOTOS</b> | | |
| | <b>Contact</b> | ANN PECHE | <b>ID</b> | 3160 | | | |

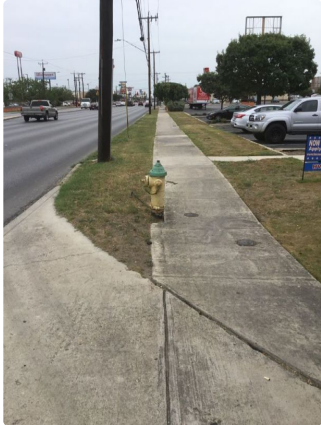
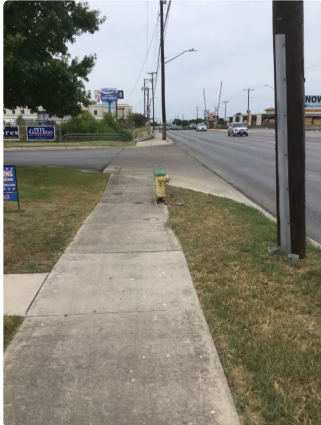
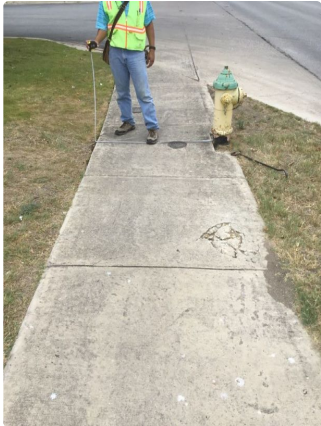
| | <b>Size and Material</b> | STANDARD FIRE HYDRANT | | | | | |
| | <b>Accessible Route</b> | ASSET IS INSIDE ACCESSIBLE ROUTE | | | | | |
| <b>RESOLUTION</b> | <b>Recommended Action</b> | NO CONFLICT | | | | | |
| | <b>Comment</b> | Hydrant to back of sidewalk = 4'-4 1/2"<br>Sidewalk width = 5'-0" | | | | | |
