Utility Conflict Report

OWNER	Utility	CPS	Corridor	SW MILITARY	SITE PHOTOS		
	Contact	JAKE MARTINEZ	ID	3161			
GENERAL INFO	Utility	ELECTRIC

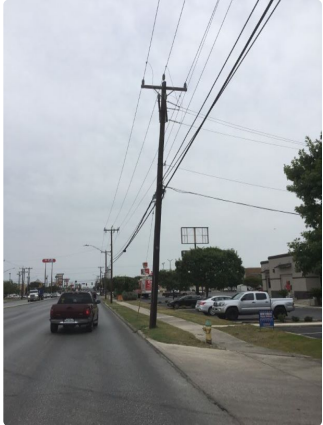
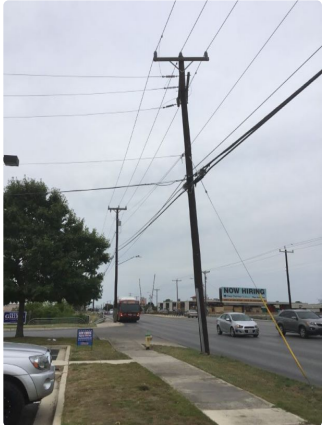
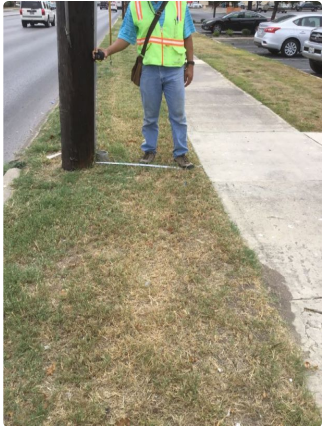
Size and Material	STANDARD POWER POLE, TIMBER					
	Accessible Route	ASSET IS OUTSIDE ACCESSIBLE ROUTE					
	Longitudinal or Crossing	CROSSING					
	Placement Relative to ROW	INSIDE ROW					
LOCATION	Sheet No.	175

Test Hole No	N/A					
	Test Hole Depth	N/A					
RESOLUTION	Recommended Action	NO CONFLICT					
	Estimated Resolution Date						
	Resolution Status	NO RESOLUTION WAS REQUIRED					
	Comment	Pole to front of sidewalk = 3'-6" Sidewalk width = 5'-0" Pole to guy wire = 22'-6" No pole ID Abandoned conduit at pole base CATV cable					
Date Collected		7/31/2018 12:44:42 PM		Date Modified		11/28/2018 6:59:12 AM
