Utility Conflict Report

OWNER	Utility	SAWS	Corridor	SW MILITARY	SITE PHOTOS	
	Contact	ANN PECHE	ID	7024		
GENERAL INFO	Utility	WATER

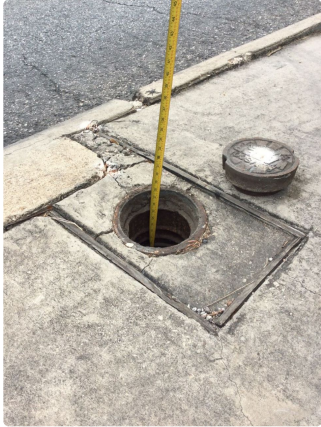
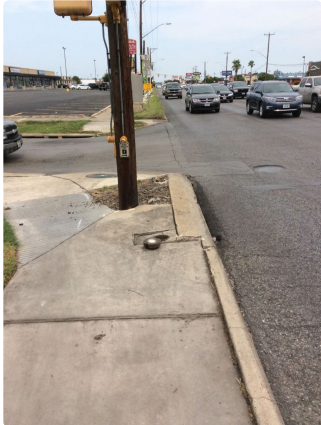
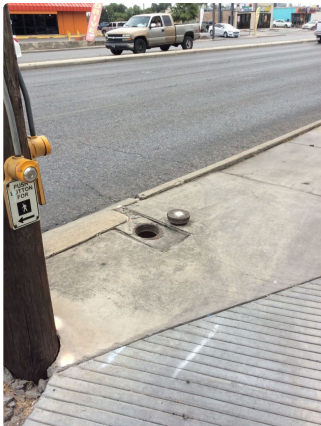
Size and Material	STANDARD WATER VALVE, CAST IRON				
	Accessible Route	ASSET IS INSIDE ACCESSIBLE ROUTE				
	Longitudinal or Crossing	CROSSING				
	Placement Relative to ROW	INSIDE ROW				
LOCATION	Sheet No.	213

Station	955+22.59				
	Offset	-16.38				
	Latitude	+29.356830				
	Longitude	-98.49909				
SUE	Level of Investigation Req'd	NONE

Estimated Resolution Date					
	Resolution Status	UTILITY OWNER INFORMED OF UTILITY				
	Comment	Top of valve to surface = 2'-3" Lid thickness = 2" Back of curb to valve = 1'-1"				
Date Collected		8/2/2018 4:22:39 PM		Date Modified	11/28/2018 6:59:12 AM

Test Hole No	N/A				
	Test Hole Depth	N/A				
RESOLUTION	Recommended Action	MINIMIZE - PROTECT IN PLACE
