## Utility Conflict Report

<b>OWNER</b>	<b>Utility</b>	SAWS	<b>Corridor</b>	SW MILITARY	<b>SITE PHOTOS</b>	
	<b>Contact</b>	ANN PECHE	<b>ID</b>	7057		
<b>GENERAL INFO</b>	<b>Utility</b>	WATER

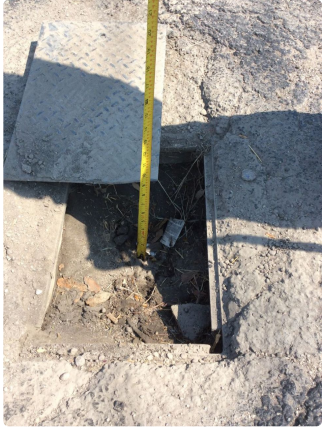
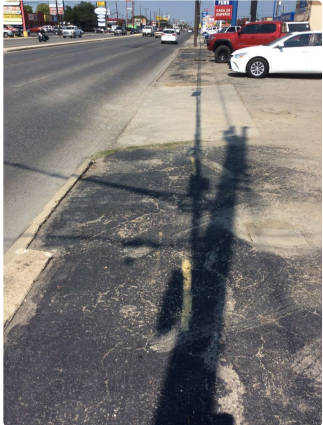
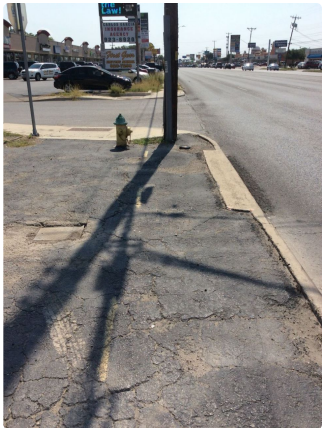
<b>Size and Material</b>	STANDARD WATER METER, STEEL				
	<b>Accessible Route</b>	ASSET IS OUTSIDE ACCESSIBLE ROUTE				
	<b>Longitudinal or Crossing</b>	CROSSING				
	<b>Placement Relative to ROW</b>	INSIDE ROW				
<b>LOCATION</b>	<b>Sheet No.</b>	206

<b>Estimated Resolution Date</b>					
	<b>Resolution Status</b>	UTILITY OWNER INFORMED OF UTILITY				
	<b>Comment</b>	Meter filled with dirt Top of dirt to surface = 9" Back of curb to meter = 5'-11"

<b>Station</b>	911+96.29				
	<b>Offset</b>	-20.3578				
	<b>Latitude</b>	+29.356845				
	<b>Longitude</b>	-98.51272				
<b>SUE</b>	<b>Level of Investigation Req'd</b>	NONE				
	<b>Test Hole No</b>	N/A				
	<b>Test Hole Depth</b>	N/A				
<b>RESOLUTION</b>	<b>Recommended Action</b>	MINIMIZE - PROTECT IN PLACE
