Utility Conflict Report

OWNER	Utility	SAWS	Corridor	SW MILITARY	SITE PHOTOS	
	Contact	ANN PECHE	ID	7086		
GENERAL INFO	Utility	WATER

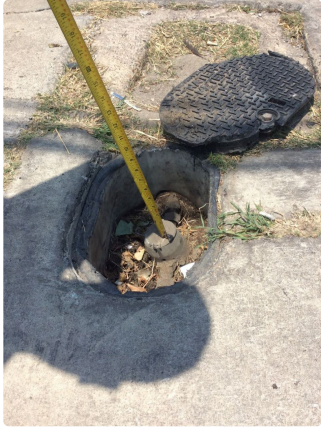
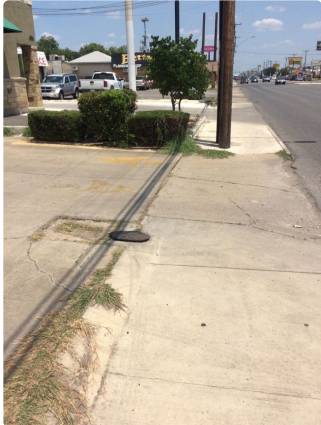
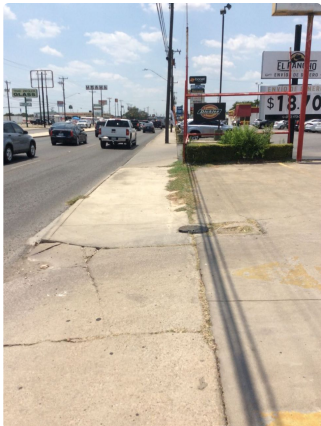
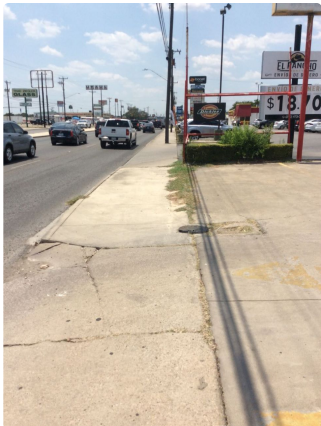
Size and Material	STANDARD WATER METER, STEEL				
	Accessible Route	ASSET IS INSIDE ACCESSIBLE ROUTE				
	Longitudinal or Crossing	CROSSING				
	Placement Relative to ROW	INSIDE ROW				
LOCATION	Sheet No.	200

Estimated Resolution Date					
	Resolution Status	UTILITY OWNER INFORMED OF UTILITY				
	Comment	Top of meter to surface = 4" Rubber lid Meter adjacent to back of sidewalk				
Date Collected		8/3/2018 2:12:24 PM		Date Modified	12/18/2018 7:57:13 AM

Test Hole No	N/A				
	Test Hole Depth	N/A				
RESOLUTION	Recommended Action	MINIMIZE - PROTECT IN PLACE
