Utility Conflict Report

OWNER	Utility	CPS	Corridor	SW MILITARY	SITE PHOTOS	
	Contact	JAKE MARTINEZ	ID	7095		
GENERAL INFO	Utility	GAS

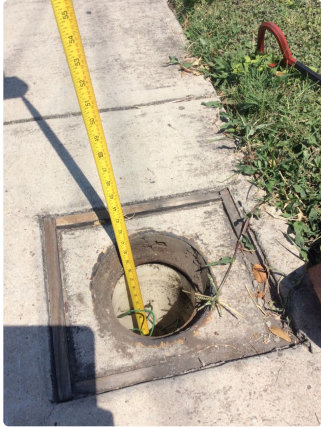
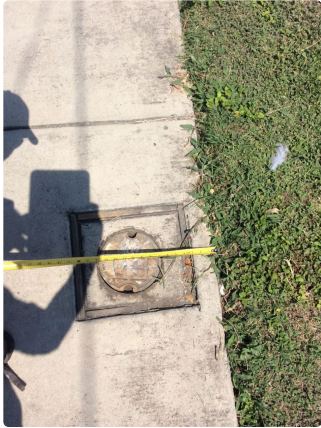
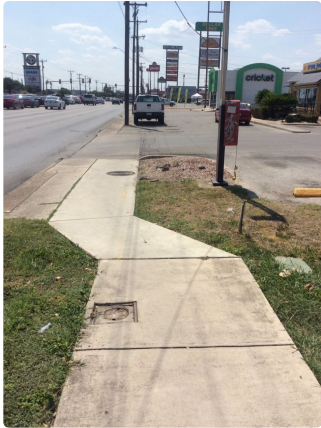
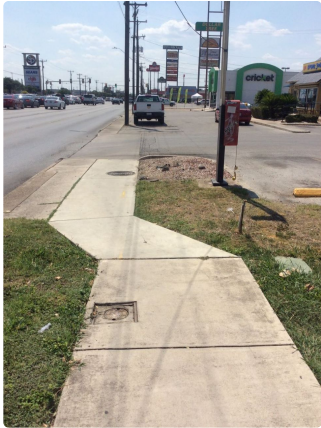
Size and Material	STANDARD GAS VALVE, CAST IRON				
	Accessible Route	ASSET IS INSIDE ACCESSIBLE ROUTE				
	Longitudinal or Crossing	CROSSING				
	Placement Relative to ROW	INSIDE ROW

Estimated Resolution Date					
	Resolution Status	NO RESOLUTION WAS REQUIRED				
	Comment	Front of sidewalk to meter = 6.5" Top of valve to surface = 3'-2" Lid thickness = 1.5"				
Date Collected		8/3/2018 3:25:22 PM	Date Modified		11/28/2018 6:59:12 AM

Test Hole No	N/A				
	Test Hole Depth	N/A				
RESOLUTION	Recommended Action	NO CONFLICT
