Utility Conflict Report

OWNER	Utility	CPS	Corridor	NOGALITOS	SITE PHOTOS		
	Contact	JAKE MARTINEZ	ID	3020			
GENERAL INFO	Utility	ELECTRIC

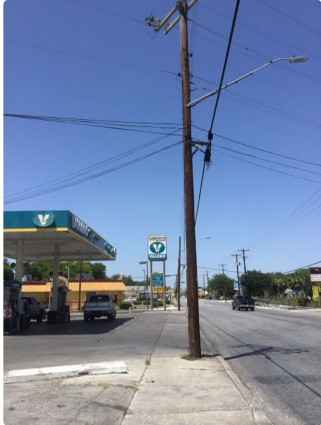
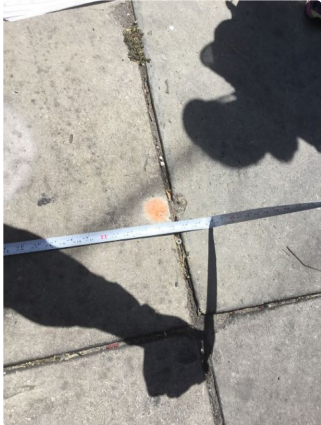
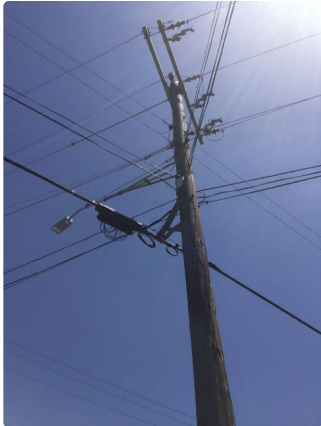
Size and Material	STANDARD POWER POLE, TIMBER					
	Accessible Route	ASSET IS INSIDE ACCESSIBLE ROUTE					
	Longitudinal or Crossing	CROSSING					
	Placement Relative to ROW	INSIDE ROW

LOCATION	Sheet No.	73					
	Station	113+35.91					
	Offset	-24.2					
	Latitude	+29.389015					
	Longitude	-98.52173					
SUE	Level of Investigation Req'd	NONE

Test Hole No	N/A					
	Test Hole Depth	N/A					
RESOLUTION	Recommended Action	MINIMIZE - PROTECT IN PLACE					
	Estimated Resolution Date						
	Resolution Status	UTILITY OWNER INFORMED OF UTILITY					
	Comment	Pole ID: R14006; LW 48600; PL 496976 Pole to back of sidewalk = 3'-6" Sidewalk width = 6'-0"					
Date Collected		7/2/2018 3:07:10 PM		Date Modified		9/13/2018 2:01:18 PM
