**CITY OF SAN MARCOS  
ADA TRANSITION PLAN  
SIGNALIZED INTERSECTION ASSESSMENT  
AND COMPLIANCE REPORT**

Location ID: 000000074  
 North-South Cross Street: SADLER DR  
 East-West Cross Street: WONDER WORLD DR

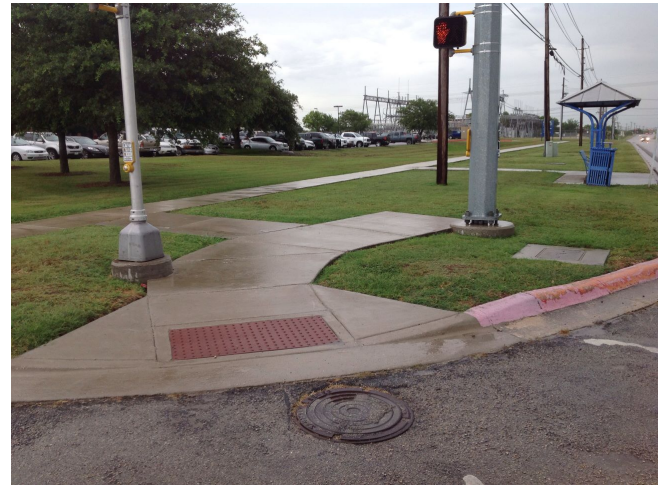
Signalized Intersection: YES  
 Accessible Features: YES  
 Pedestrian Features Accessible: YES

<b>Ramp Elements</b>	Curb ramp provided where an accessible route crosses a barrier:	YES
	Is the slope of the ramp 1:12 or less:	YES
	Transition from curb ramp slope to roadway free from abrupt changes, no greater than 1:20:	YES
	Ramp is at least 36" wide:	YES
	Ramp surface is stable, firm, and slip resistant:	YES
<b>Flare</b>	Flares (if present) are 1:10 or less measured along the curb line; or If landing at top of ramp is not provided flares are 1:12 or less:	YES
<b>Detectable Warning Surface</b>	Curb ramp is located such that it does not project into roadway or parking aisles:	N/A
	Detectable warning is present:	YES
	DWS maintains correct geometric controls; 0.9" diameter domes, 0.2" in height, spaced at 2.35" and visually contrasts adjacent ramp surface:	YES
<b>Special Ramps</b>	Ramp maintains defined edges parallel to direction of pedestrian travel; maintains 4'x4' turning pad contained in crosswalk; flared sides 24" segment on each side of ramp within crosswalk lines:	YES

Ramp is located so they will not be obstructed by parked vehicles:	N/A
	Ramp wholly contained within the crosswalk lines:	YES
	If island is present; Island maintains a cut through at street level or ramps on either side with landing between them:	N/A
