**CITY OF SAN MARCOS
ADA TRANSITION PLAN
SIGNALIZED INTERSECTION ASSESSMENT
AND COMPLIANCE REPORT**

Location ID: 000000077
 North-South Cross Street: SH 123
 East-West Cross Street: DE ZAVALA DR

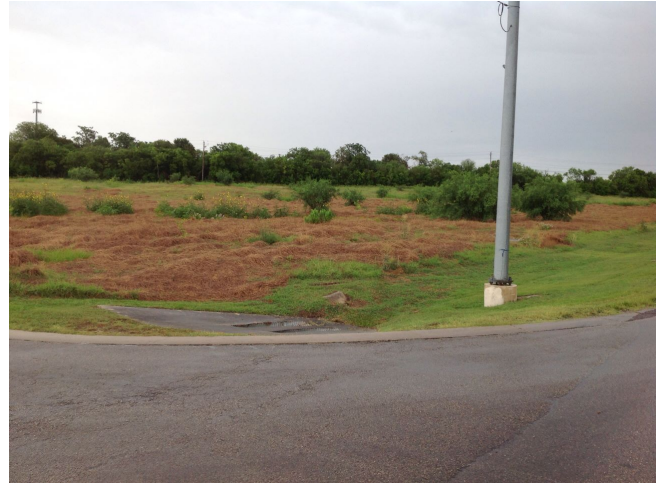
Signalized Intersection: YES
 Accessible Features: NO
 Pedestrian Features Accessible: NO

Ramp Elements	Curb ramp provided where an accessible route crosses a barrier:	NO
	Is the slope of the ramp 1:12 or less:	NO
	Transition from curb ramp slope to roadway free from abrupt changes, no greater than 1:20:	NO
	Ramp is at least 36" wide:	NO
	Ramp surface is stable, firm, and slip resistant:	NO
Flare	Flares (if present) are 1:10 or less measured along the curb line; or If landing at top of ramp is not provided flares are 1:12 or less:	NO
Detectable Warning Surface	Curb ramp is located such that it does not project into roadway or parking aisles:	N/A
	Detectable warning is present:	NO
	DWS maintains correct geometric controls; 0.9" diameter domes, 0.2" in height, spaced at 2.35" and visually contracts adjacent ramp surface:	NO
Special Ramps	Ramp maintains defined edges parallel to direction of pedestrian travel; maintains 4'x4' turning pad contained in crosswalk; flared sides 24" segment on each side of ramp within crosswalk lines:	N/A

Ramp is located so they will not be obstructed by parked vehicles:	N/A
	Ramp wholly contained within the crosswalk lines:	N/A
	If island is present; Island maintains a cut through at street level or ramps on either side with landing between them:	N/A
