**CITY OF SAN MARCOS
ADA TRANSITION PLAN
SIGNALIZED INTERSECTION ASSESSMENT
AND COMPLIANCE REPORT**

Location ID: 000000078
 North-South Cross Street: SH 123
 East-West Cross Street: BROADWAY ST

Location ID: 000000078

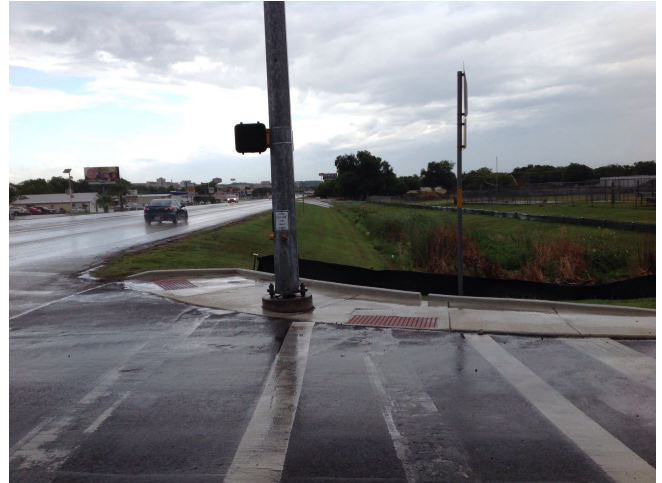
Signalized Intersection: YES
 Accessible Features: YES
 Pedestrian Features Accessible: YES

Ramp Elements	Curb ramp provided where an accessible route crosses a barrier:	YES
	Is the slope of the ramp 1:12 or less:	YES
	Transition from curb ramp slope to roadway free from abrupt changes, no greater than 1:20:	YES
	Ramp is at least 36" wide:	YES
	Ramp surface is stable, firm, and slip resistant:	YES
Flare	Flares (if present) are 1:10 or less measured along the curb line; or If landing at top of ramp is not provided flares are 1:12 or less:	N/A
Detectable Warning Surface	Curb ramp is located such that it does not project into roadway or parking aisles:	N/A
	Detectable warning is present:	YES
	DWS maintains correct geometric controls; 0.9" diameter domes, 0.2" in height, spaced at 2.35" and visually contracts adjacent ramp surface:	
Special Ramps	Ramp maintains defined edges parallel to direction of pedestrian travel; maintains 4'x4' turning pad contained in crosswalk; flared sides 24" segment on each side of ramp within crosswalk lines:	N/A

Ramp is located so they will not be obstructed by parked vehicles:	N/A
	Ramp wholly contained within the crosswalk lines:	YES
	If island is present; Island maintains a cut through at street level or ramps on either side with landing between them:	N/A
