CITY OF SAN MARCOS ADA TRANSITION PLAN SIGNALIZED INTERSECTION ASSESSMENT AND COMPLIANCE REPORT

Location ID: 0000000091
 North-South Cross Street: LBJ DR
 East-West Cross Street: CHEATHAM ST

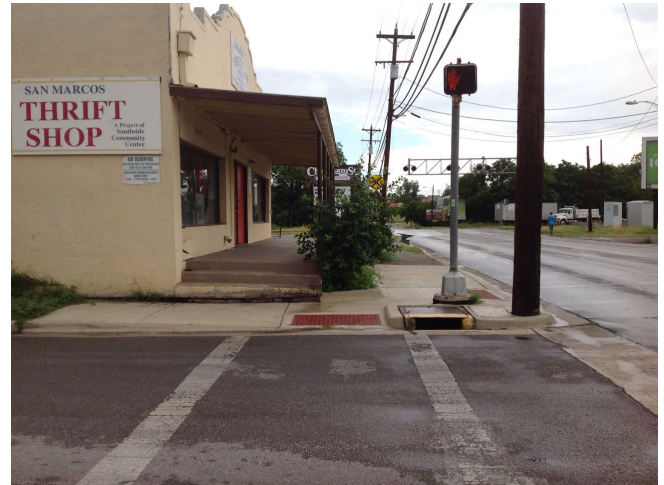
Signalized Intersection: YES
 Accessible Features: NO
 Pedestrian Features Accessible: NO

Ramp Elements	Curb ramp provided where an accessible route crosses a barrier:	YES
	Is the slope of the ramp 1:12 or less:	YES
	Transition from curb ramp slope to roadway free from abrupt changes, no greater than 1:20:	YES
	Ramp is at least 36" wide:	YES
	Ramp surface is stable, firm, and slip resistant:	YES
Flare	Flares (if present) are 1:10 or less measured along the curb line; or If landing at top of ramp is not provided flares are 1:12 or less:	YES
Detectable Warning Surface	Curb ramp is located such that it does not project into roadway or parking aisles:	N/A
	Detectable warning is present:	YES
	DWS maintains correct geometric controls; 0.9" diameter domes, 0.2" in height, spaced at 2.35" and visually contracts adjacent ramp surface:	YES
Special Ramps	Ramp maintains defined edges parallel to direction of pedestrian travel; maintains 4'x4' turning pad contained in crosswalk; flared sides 24" segment on each side of ramp within crosswalk lines:	N/A

Ramp is located so they will not be obstructed by parked vehicles:	N/A
	Ramp wholly contained within the crosswalk lines:	YES
	If island is present; Island maintains a cut through at street level or ramps on either side with landing between them:	N/A
