**CITY OF SAN MARCOS  
ADA TRANSITION PLAN  
SIGNALIZED INTERSECTION ASSESSMENT  
AND COMPLIANCE REPORT**

Location ID: 0000000094  
 North-South Cross Street: HOPKINS ST  
 East-West Cross Street: BISHOP ST

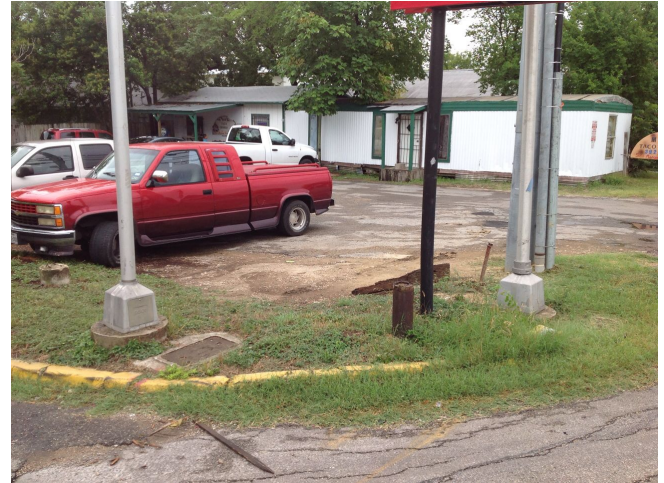
Signalized Intersection: YES  
 Accessible Features: NO  
 Pedestrian Features Accessible: NO

<b>Ramp Elements</b>	Curb ramp provided where an accessible route crosses a barrier:	NO
	Is the slope of the ramp 1:12 or less:	NO
	Transition from curb ramp slope to roadway free from abrupt changes, no greater than 1:20:	NO
	Ramp is at least 36" wide:	NO
	Ramp surface is stable, firm, and slip resistant:	NO
<b>Flare</b>	Flares (if present) are 1:10 or less measured along the curb line; or If landing at top of ramp is not provided flares are 1:12 or less:	NO
<b>Detectable Warning Surface</b>	Curb ramp is located such that it does not project into roadway or parking aisles:	N/A
	Detectable warning is present:	NO
	DWS maintains correct geometric controls; 0.9" diameter domes, 0.2" in height, spaced at 2.35" and visually contracts adjacent ramp surface:	NO
<b>Special Ramps</b>	Ramp maintains defined edges parallel to direction of pedestrian travel; maintains 4'x4' turning pad contained in crosswalk; flared sides 24" segment on each side of ramp within crosswalk lines:	N/A

Ramp is located so they will not be obstructed by parked vehicles:	N/A
	Ramp wholly contained within the crosswalk lines:	N/A
	If island is present; Island maintains a cut through at street level or ramps on either side with landing between them:	N/A
