**CITY OF SAN MARCOS  
ADA TRANSITION PLAN  
SIGNALIZED INTERSECTION ASSESSMENT  
AND COMPLIANCE REPORT**

Location ID: 0000000095  
 North-South Cross Street: HOPKINS ST  
 East-West Cross Street: BISHOP ST

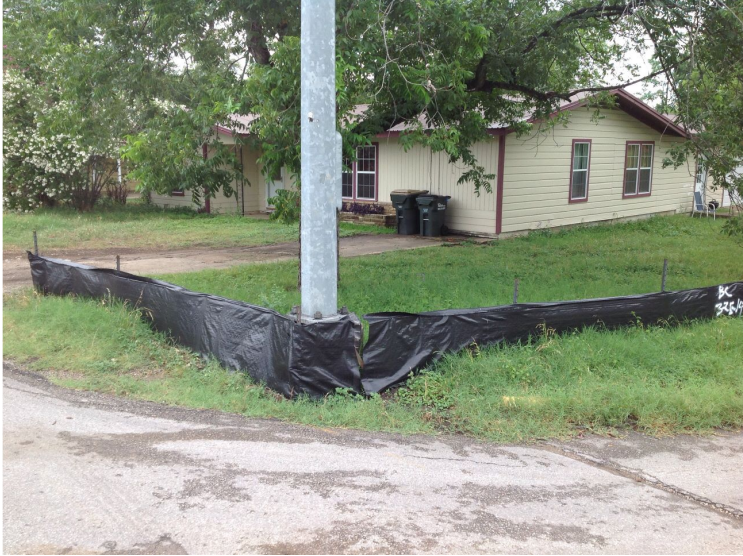
**Location Photos**

<b>Ramp Elements</b>	Curb ramp provided where an accessible route crosses a barrier:	NO
	Is the slope of the ramp 1:12 or less:	NO
	Transition from curb ramp slope to roadway free from abrupt changes, no greater than 1:20:	NO
	Ramp is at least 36" wide:	NO
	Ramp surface is stable, firm, and slip resistant:	NO
<b>Flare</b>	Flares (if present) are 1:10 or less measured along the curb line; or If landing at top of ramp is not provided flares are 1:12 or less:	NO
<b>Detectable Warning Surface</b>	Curb ramp is located such that it does not project into roadway or parking aisles:	N/A
	Detectable warning is present:	NO
	DWS maintains correct geometric controls; 0.9" diameter domes, 0.2" in height, spaced at 2.35" and visually contracts adjacent ramp surface:	NO
<b>Special Ramps</b>	Ramp maintains defined edges parallel to direction of pedestrian travel; maintains 4'x4' turning pad contained in crosswalk; flared sides 24" segment on each side of ramp within crosswalk lines:	N/A

Ramp is located so they will not be obstructed by parked vehicles:	N/A
	Ramp wholly contained within the crosswalk lines:	N/A
	If island is present; Island maintains a cut through at street level or ramps on either side with landing between them:	N/A
