CITY OF SAN MARCOS ADA TRANSITION PLAN SIGNALIZED INTERSECTION ASSESSMENT AND COMPLIANCE REPORT

Location ID: 0000000099
 North-South Cross Street: HUNTER RD
 East-West Cross Street: WONDER WORLD DR

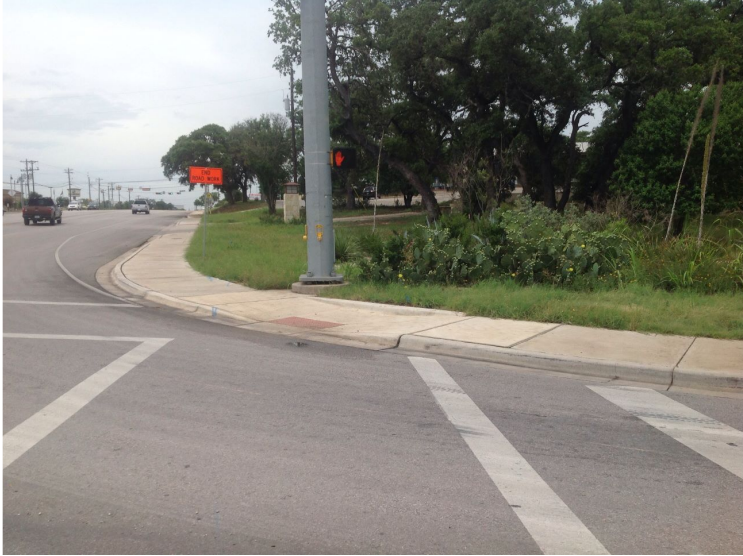
Location Photos

Ramp Elements	Curb ramp provided where an accessible route crosses a barrier:	YES
	Is the slope of the ramp 1:12 or less:	YES
	Transition from curb ramp slope to roadway free from abrupt changes, no greater than 1:20:	YES
	Ramp is at least 36" wide:	YES
	Ramp surface is stable, firm, and slip resistant:	YES
Flare	Flares (if present) are 1:10 or less measured along the curb line; or If landing at top of ramp is not provided flares are 1:12 or less:	N/A
Detectable Warning Surface	Curb ramp is located such that it does not project into roadway or parking aisles:	N/A
	Detectable warning is present:	YES
	DWS maintains correct geometric controls; 0.9" diameter domes, 0.2" in height, spaced at 2.35" and visually contracts adjacent ramp surface:	YES
Special Ramps	Ramp maintains defined edges parallel to direction of pedestrian travel; maintains 4'x4' turning pad contained in crosswalk; flared sides 24" segment on each side of ramp within crosswalk lines:	YES

Ramp is located so they will not be obstructed by parked vehicles:	N/A
	Ramp wholly contained within the crosswalk lines:	YES
	If island is present; Island maintains a cut through at street level or ramps on either side with landing between them:	N/A
