**CITY OF SAN MARCOS  
ADA TRANSITION PLAN  
SIGNALIZED INTERSECTION ASSESSMENT  
AND COMPLIANCE REPORT**

Location ID: 0000000107  
 North-South Cross Street: CRADDOCK AVE  
 East-West Cross Street: RM 12

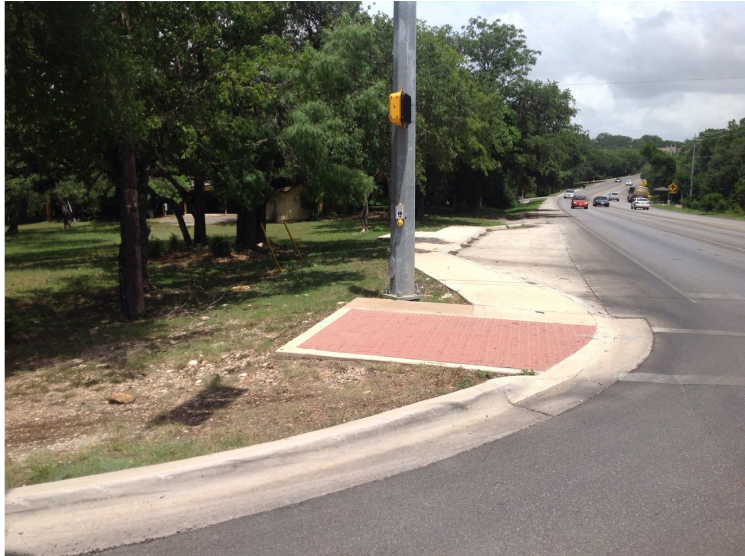
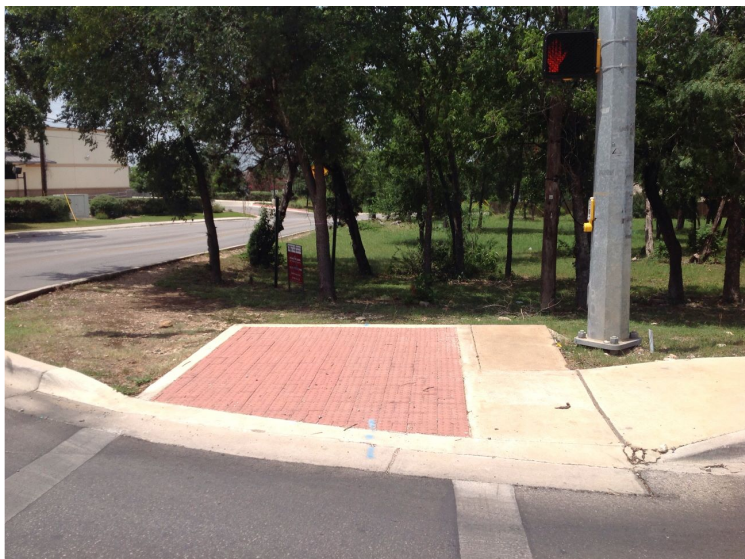
**Location Photos**

<b>Ramp Elements</b>	Curb ramp provided where an accessible route crosses a barrier:	YES
	Is the slope of the ramp 1:12 or less:	YES
	Transition from curb ramp slope to roadway free from abrupt changes, no greater than 1:20:	YES
	Ramp is at least 36" wide:	YES
	Ramp surface is stable, firm, and slip resistant:	YES
<b>Flare</b>	Flares (if present) are 1:10 or less measured along the curb line; or If landing at top of ramp is not provided flares are 1:12 or less:	N/A
<b>Detectable Warning Surface</b>	Curb ramp is located such that it does not project into roadway or parking aisles:	N/A
	Detectable warning is present:	YES
	DWS maintains correct geometric controls; 0.9" diameter domes, 0.2" in height, spaced at 2.35" and visually contracts adjacent ramp surface:	NO
<b>Special Ramps</b>	Ramp maintains defined edges parallel to direction of pedestrian travel; maintains 4'x4' turning pad contained in crosswalk; flared sides 24" segment on each side of ramp within crosswalk lines:	N/A

Ramp is located so they will not be obstructed by parked vehicles:	N/A
	Ramp wholly contained within the crosswalk lines:	YES
	If island is present; Island maintains a cut through at street level or ramps on either side with landing between them:	N/A
